Re: EPR Master Development Planning  
Draft Phase I Environmental Assessment  
Empire Resorts Parcels 1 and 2

## EXECUTIVE SUMMARY

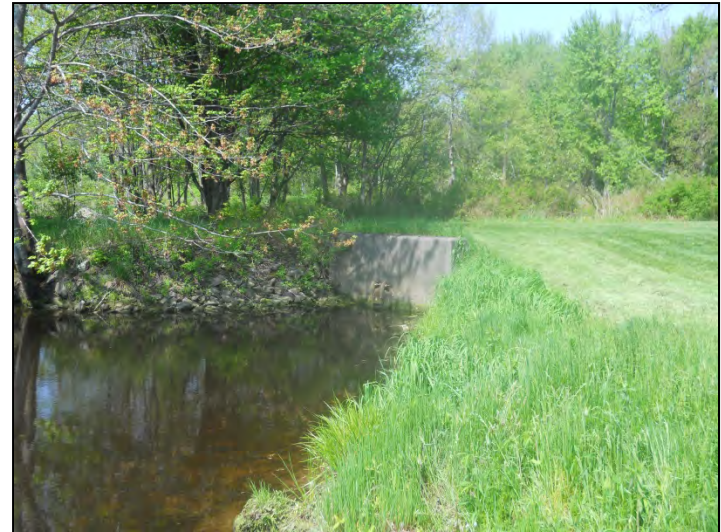
Photograph 3: Water hazard at Concord Monster golf course near Hole 3.

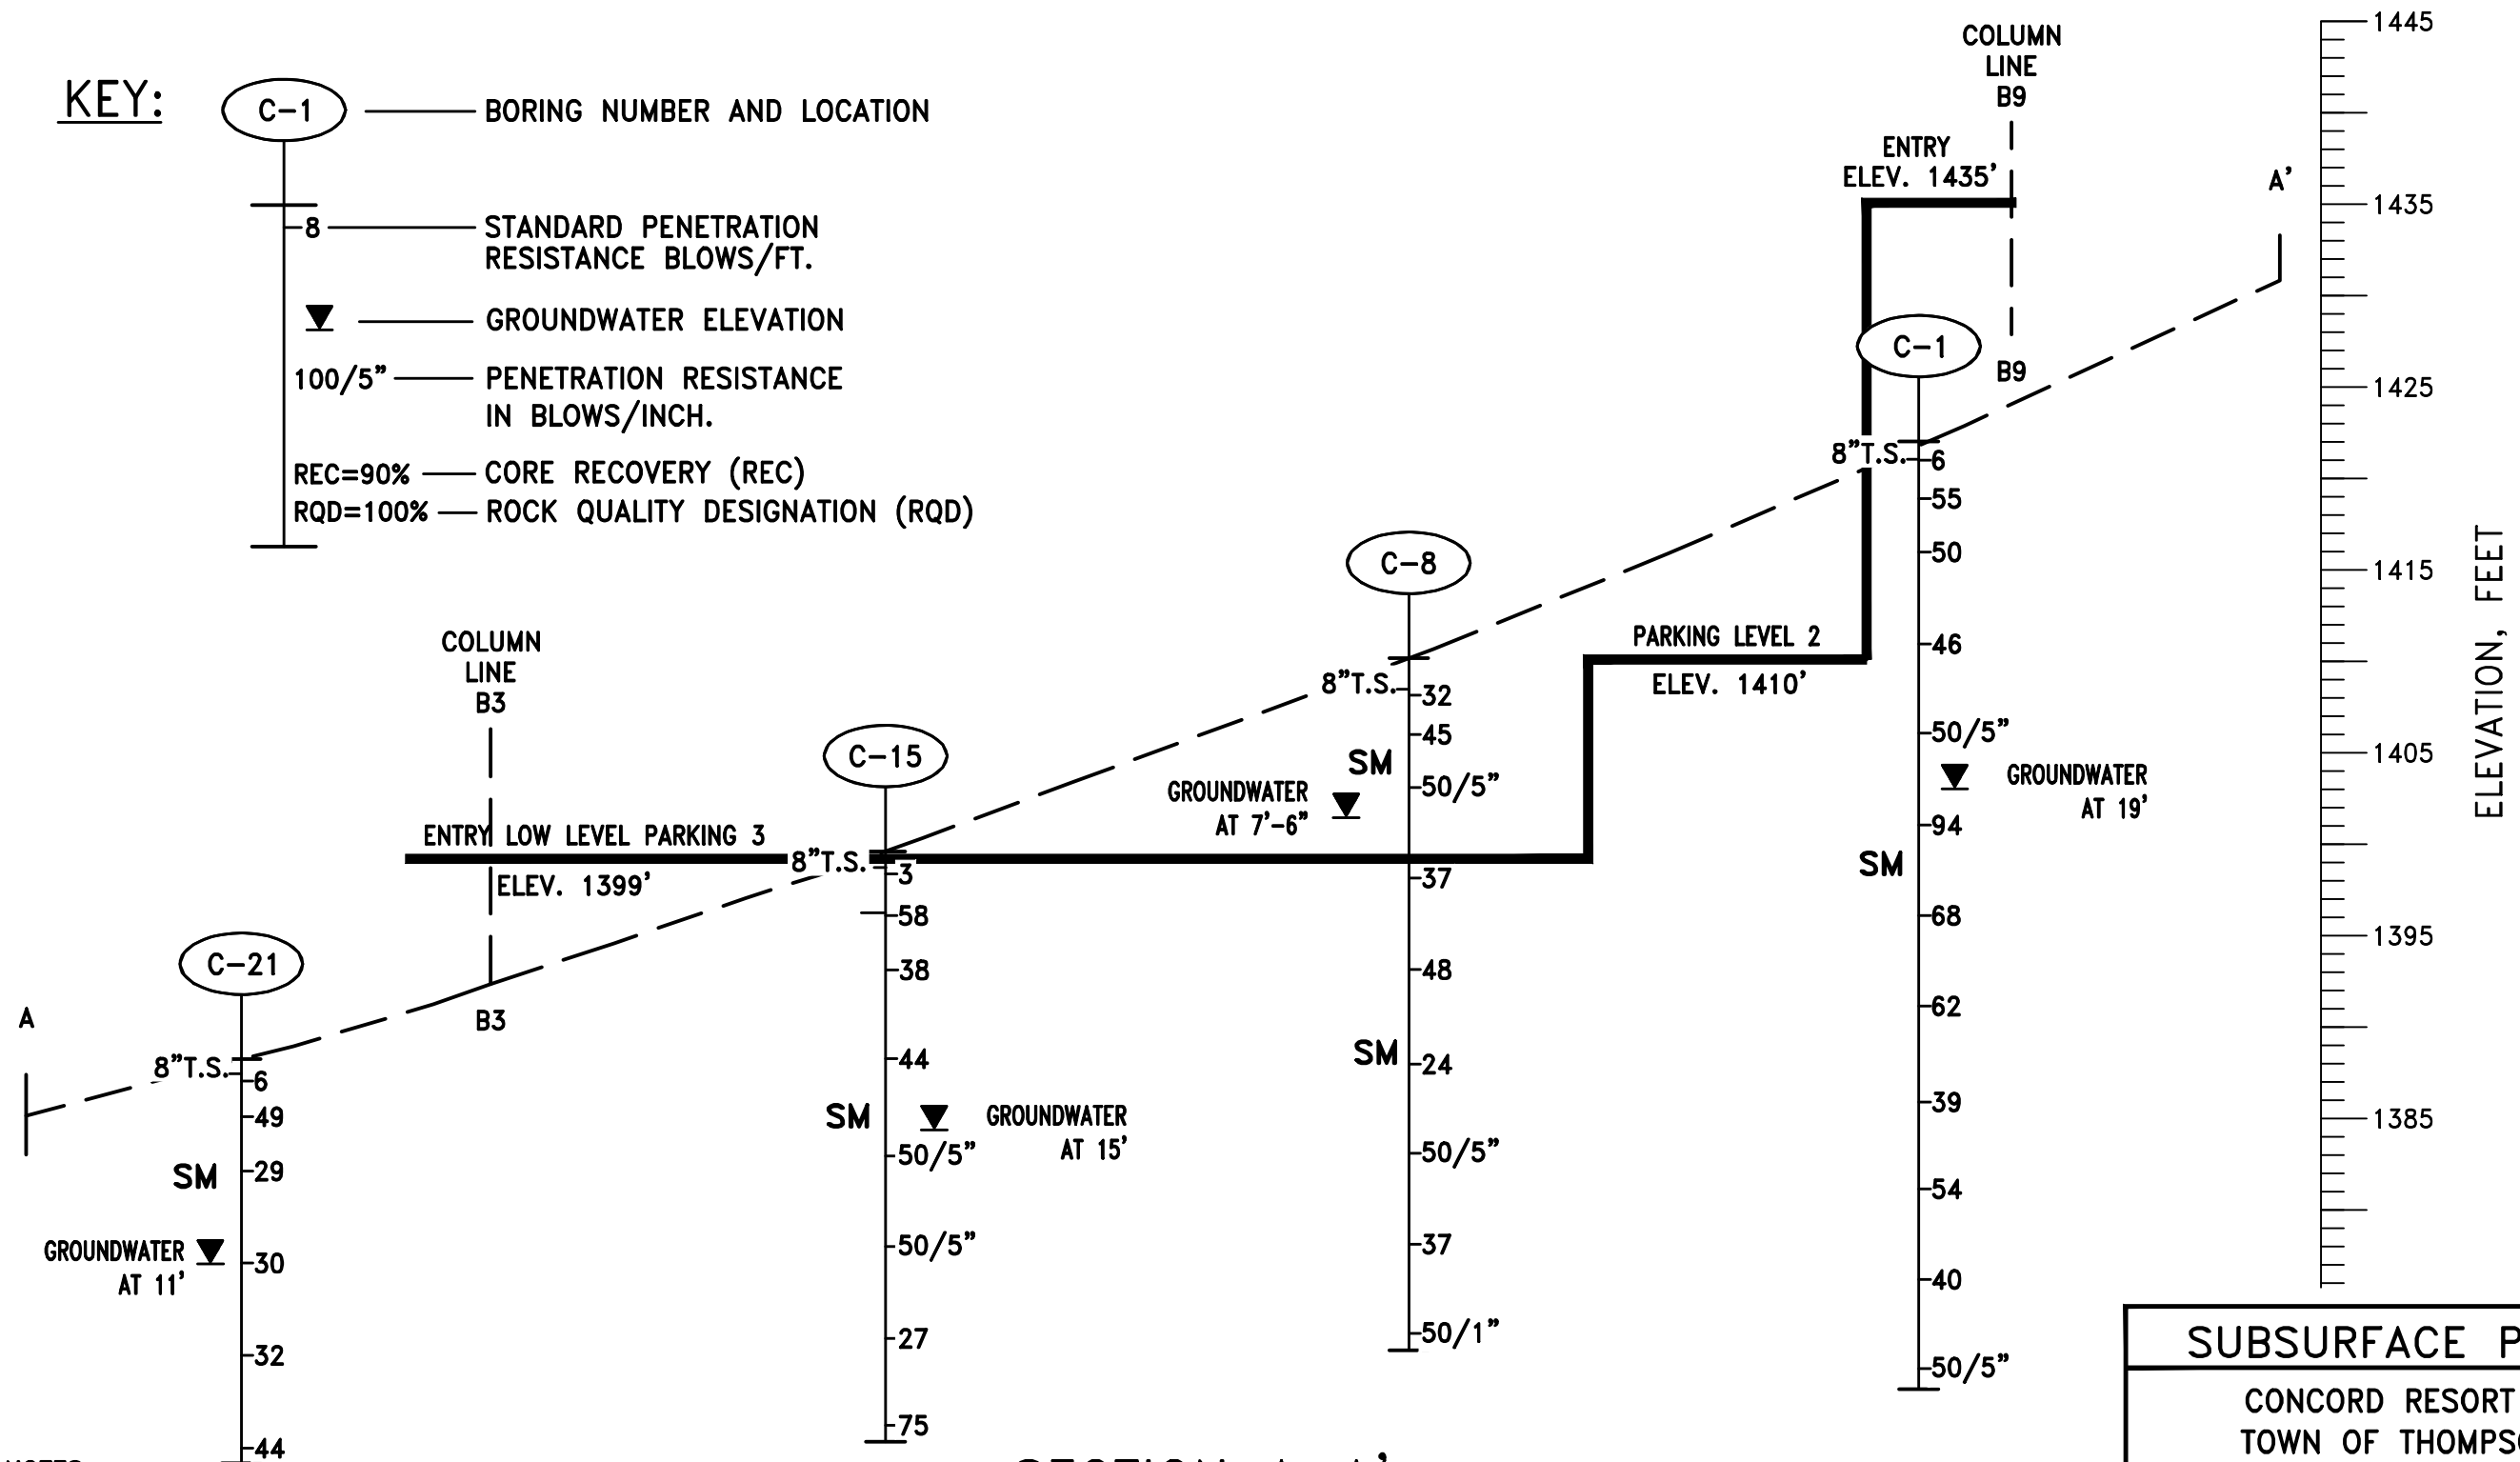
# SECTION A-A'

- C-1 — BORING NUMBER AND LOCATION
- 8— STANDARD PENETRATION RESISTANCE BLOWS/FT.
- ▼ — GROUNDWATER ELEVATION
- 100/5" — PENETRATION RESISTANCE IN BLOWS/INCH.
- REC=90% — CORE RECOVERY (REC)
- RQD=100% — ROCK QUALITY DESIGNATION (RQD)
