**REMEDIAL INVESTIGATION AND
INTERIM REMEDIAL MEASURE
(RI/IRM) WORK PLAN**

**THE CONCORD HOTEL & RESORT SITE
Concord Road, Kiamesha Lake
Thompson, NY 12751**

October 2004

**JM Associates, Inc.
225 Railroad Ave
Bedford Hills, NY 10507**

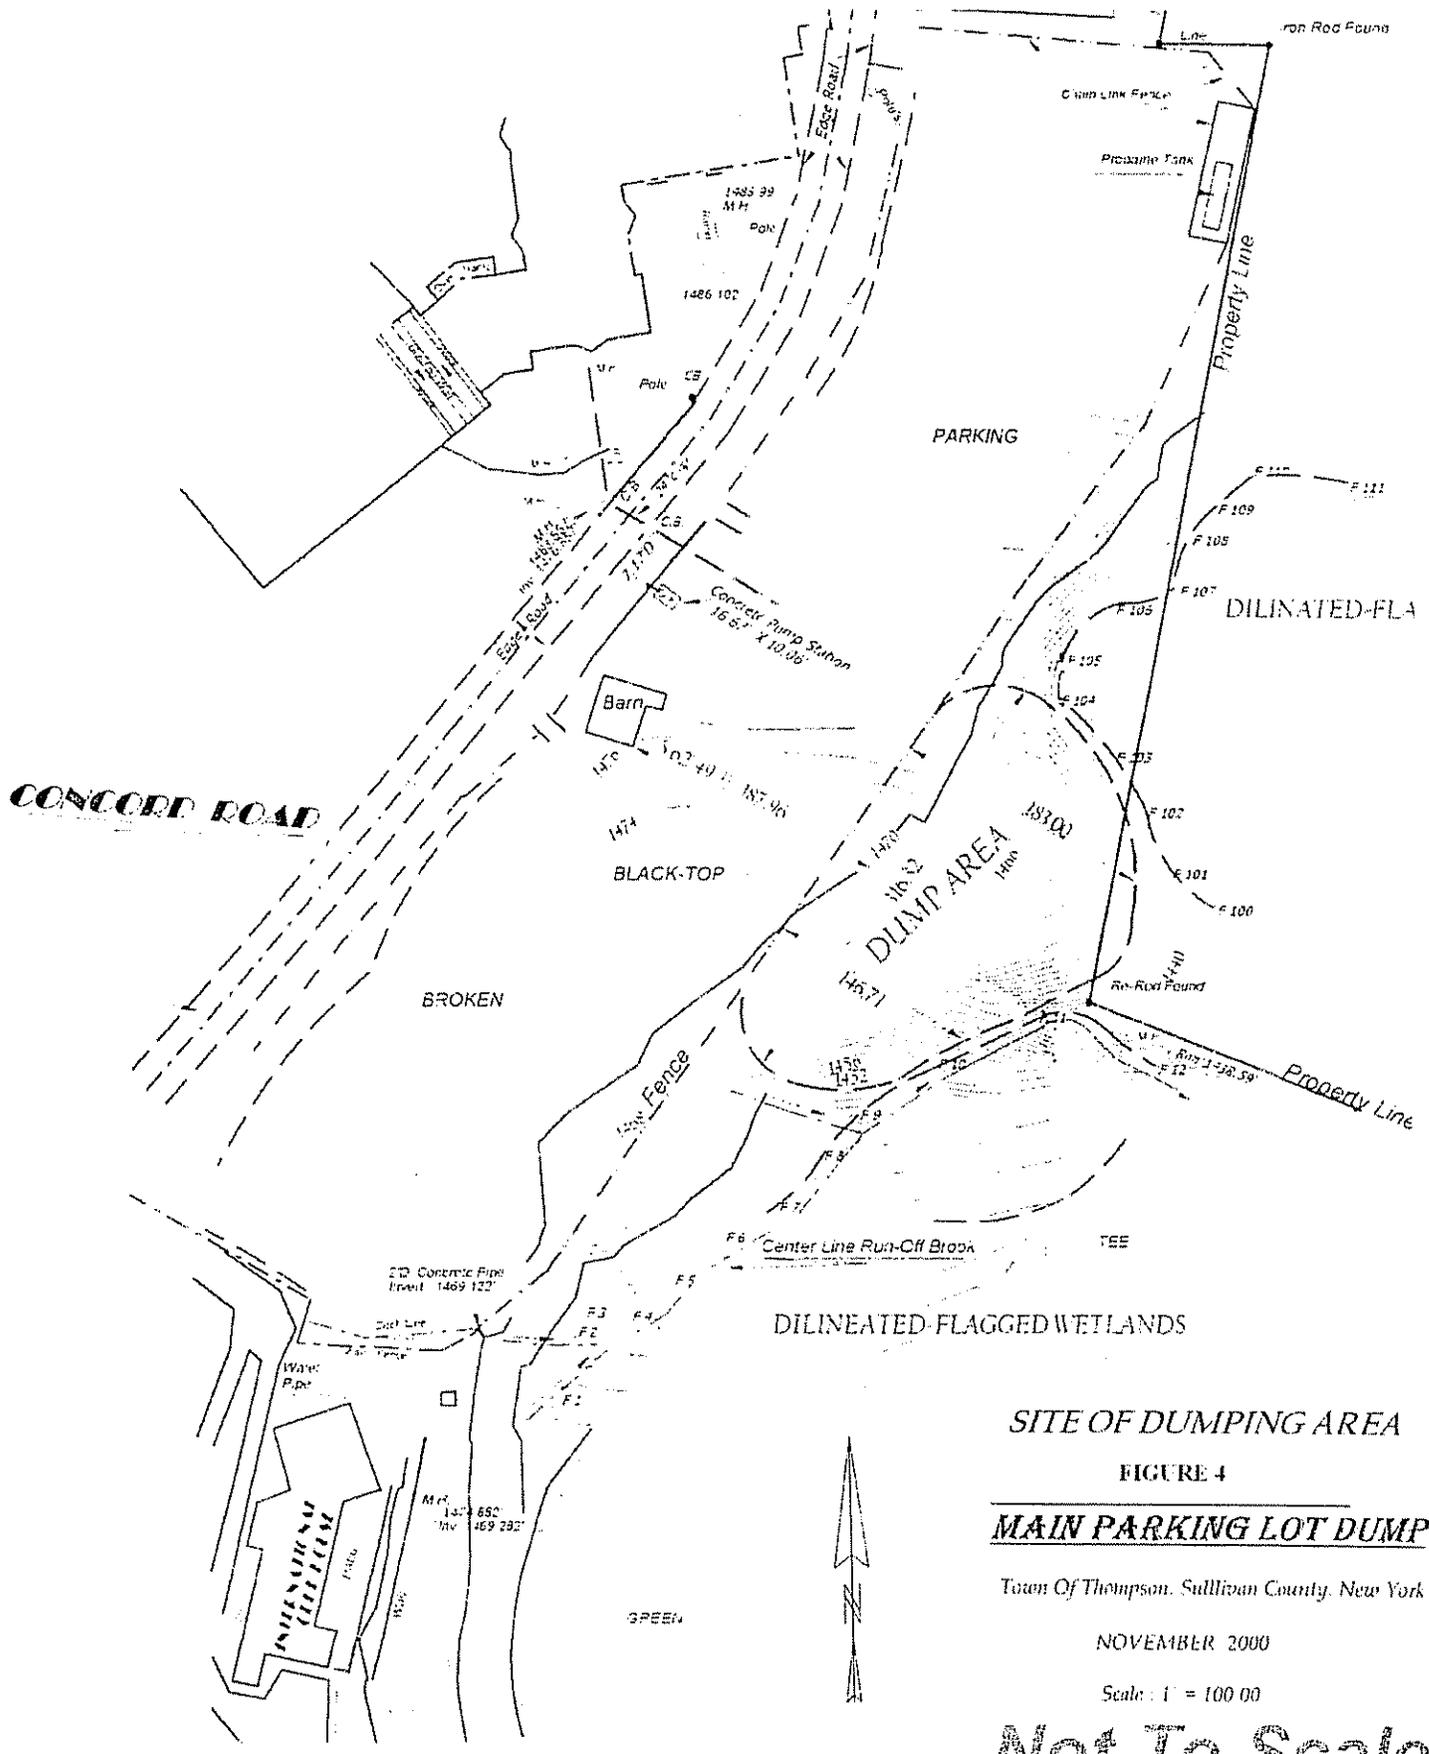
FIGURE 4

SITE OF DUMPING AREA

• PULL BACK EDGE WASTE
 Assume 10' wide x 20' DEEP
 x 400' PERIMETER ≈ 2,900 cu. yd.

The Main Parking Area Dump Site is located east of the Hotel main parking area and adjacent to an unnamed tributary of Kiamesha Creek and a federally regulated wetland. As determined from the test pit investigation conducted during the Phase II, the area of the dump site is approximately 0.53 acres with an estimated volume of 3,000 cubic yards of waste. Groundwater seeps were observed at three locations at the base of the waste during the Phase II. The material observed in the dump was also stained by leachate. The age of the waste was estimated to be from the 1980's through the early 1990's and consisted of white goods, drapes, cloth, glass bottles, carpeting, assorted wood, bricks, scrap metals and tires. The map of the Dump is shown in Figure 4.

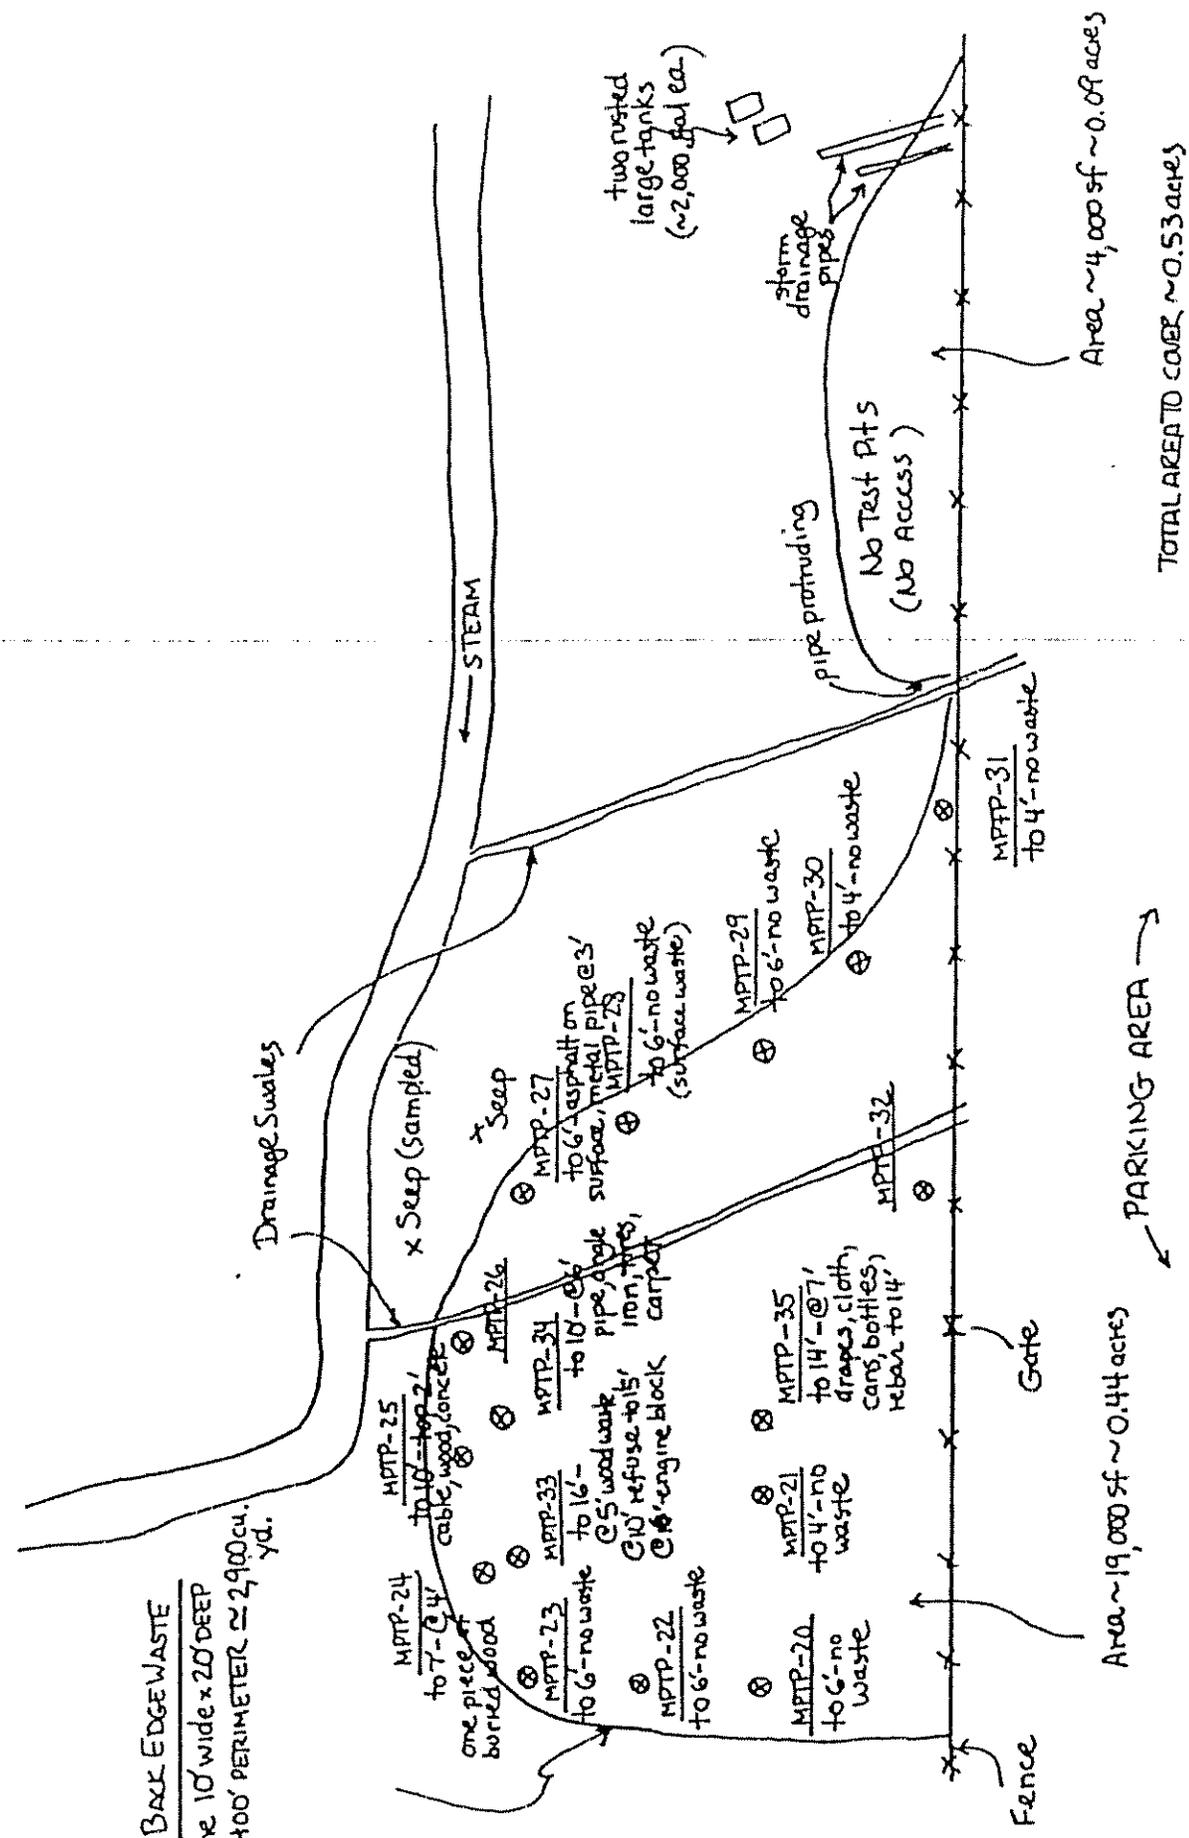
MPTP-24 to 7'-@ 4' buried wood

MPTP-25 to 10'-top 2' cable, wood, concrete

A total of fifteen (15) test pits were installed during the Phase II. The depth of the test pits ranged from 4 feet to 16 feet. Soil samples were collected from the base of the waste from four (4) of the test pits. Two samples were collected at a depth of 15 feet and two from a depth of 16 feet. The samples included RCRA and TCLP tests to determine if the waste was hazardous or nonhazardous. All sample results indicated that the waste is non-hazardous. The locations of the test pits completed in the Phase II are shown in Figure 5.

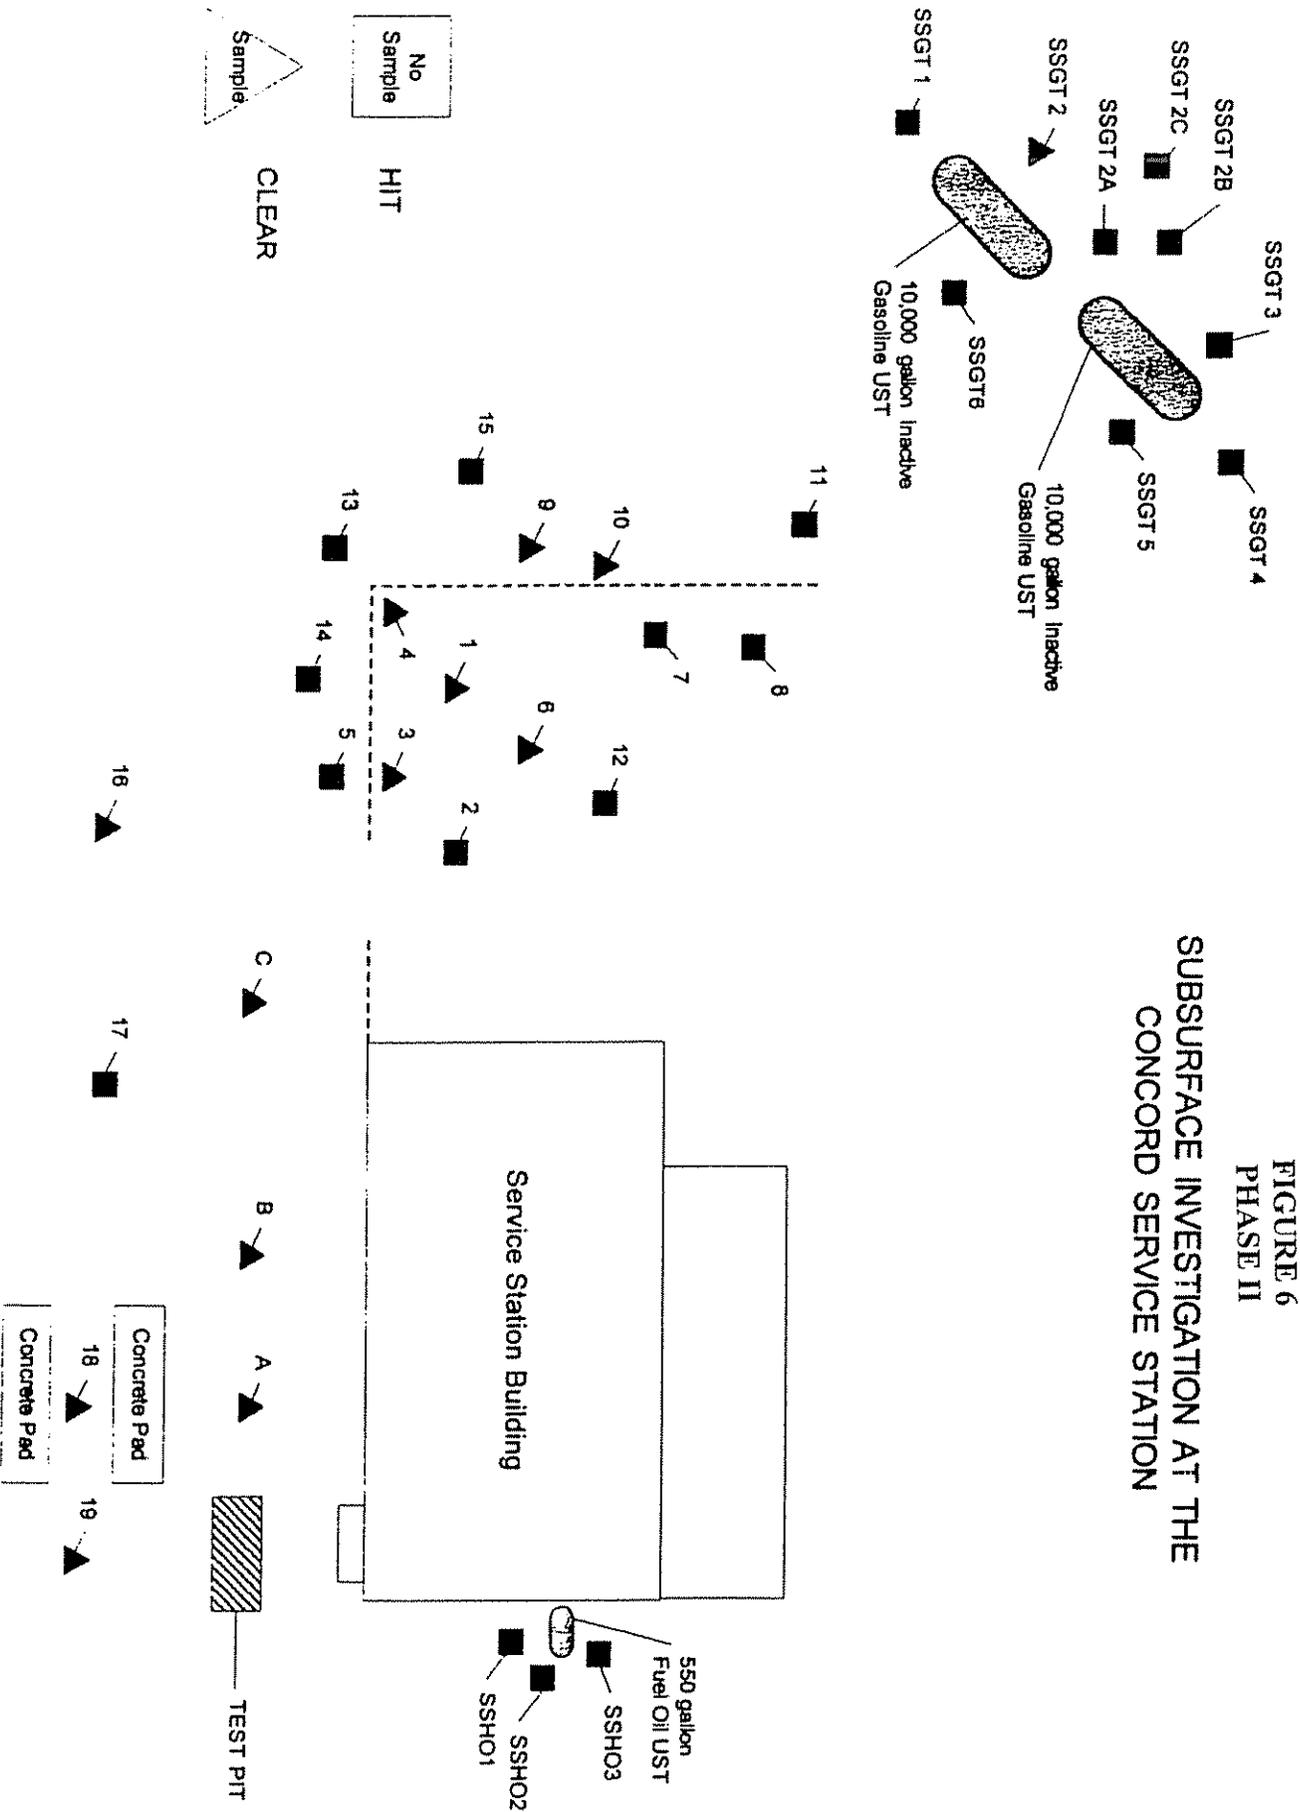
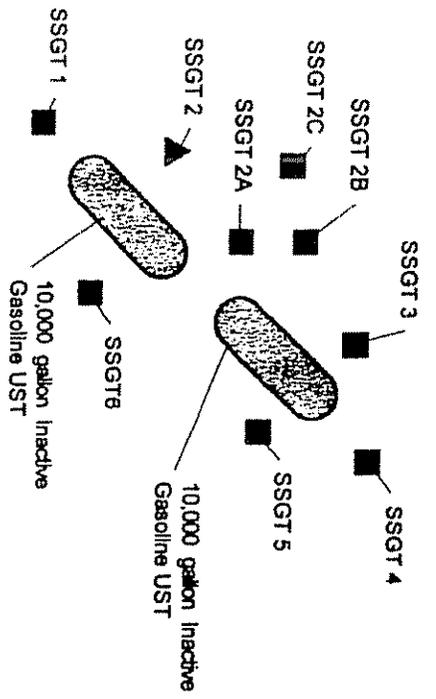
FIGURE 6
PHASE II

SUBSURFACE INVESTIGATION AT THE
CONCORD SERVICE STATION

During the Phase II, a subsurface investigation was completed in areas known to be the location of prior tanks and/or product transfer lines. An area located northeast of the service station building where former USTs were located was investigated and found to contain petroleum contaminated soils and groundwater. Six (6) soil samples and two (2) groundwater samples were collected and analyzed. The results are summarized in Table 1. An area in front of the building where tank islands and USTs were once located was also investigated and determined to be contaminated with petroleum products. Six (6) soil samples were collected and analyzed from this area. Groundwater was not encountered and was not sampled. The results from this area are also summarized in Table 1.

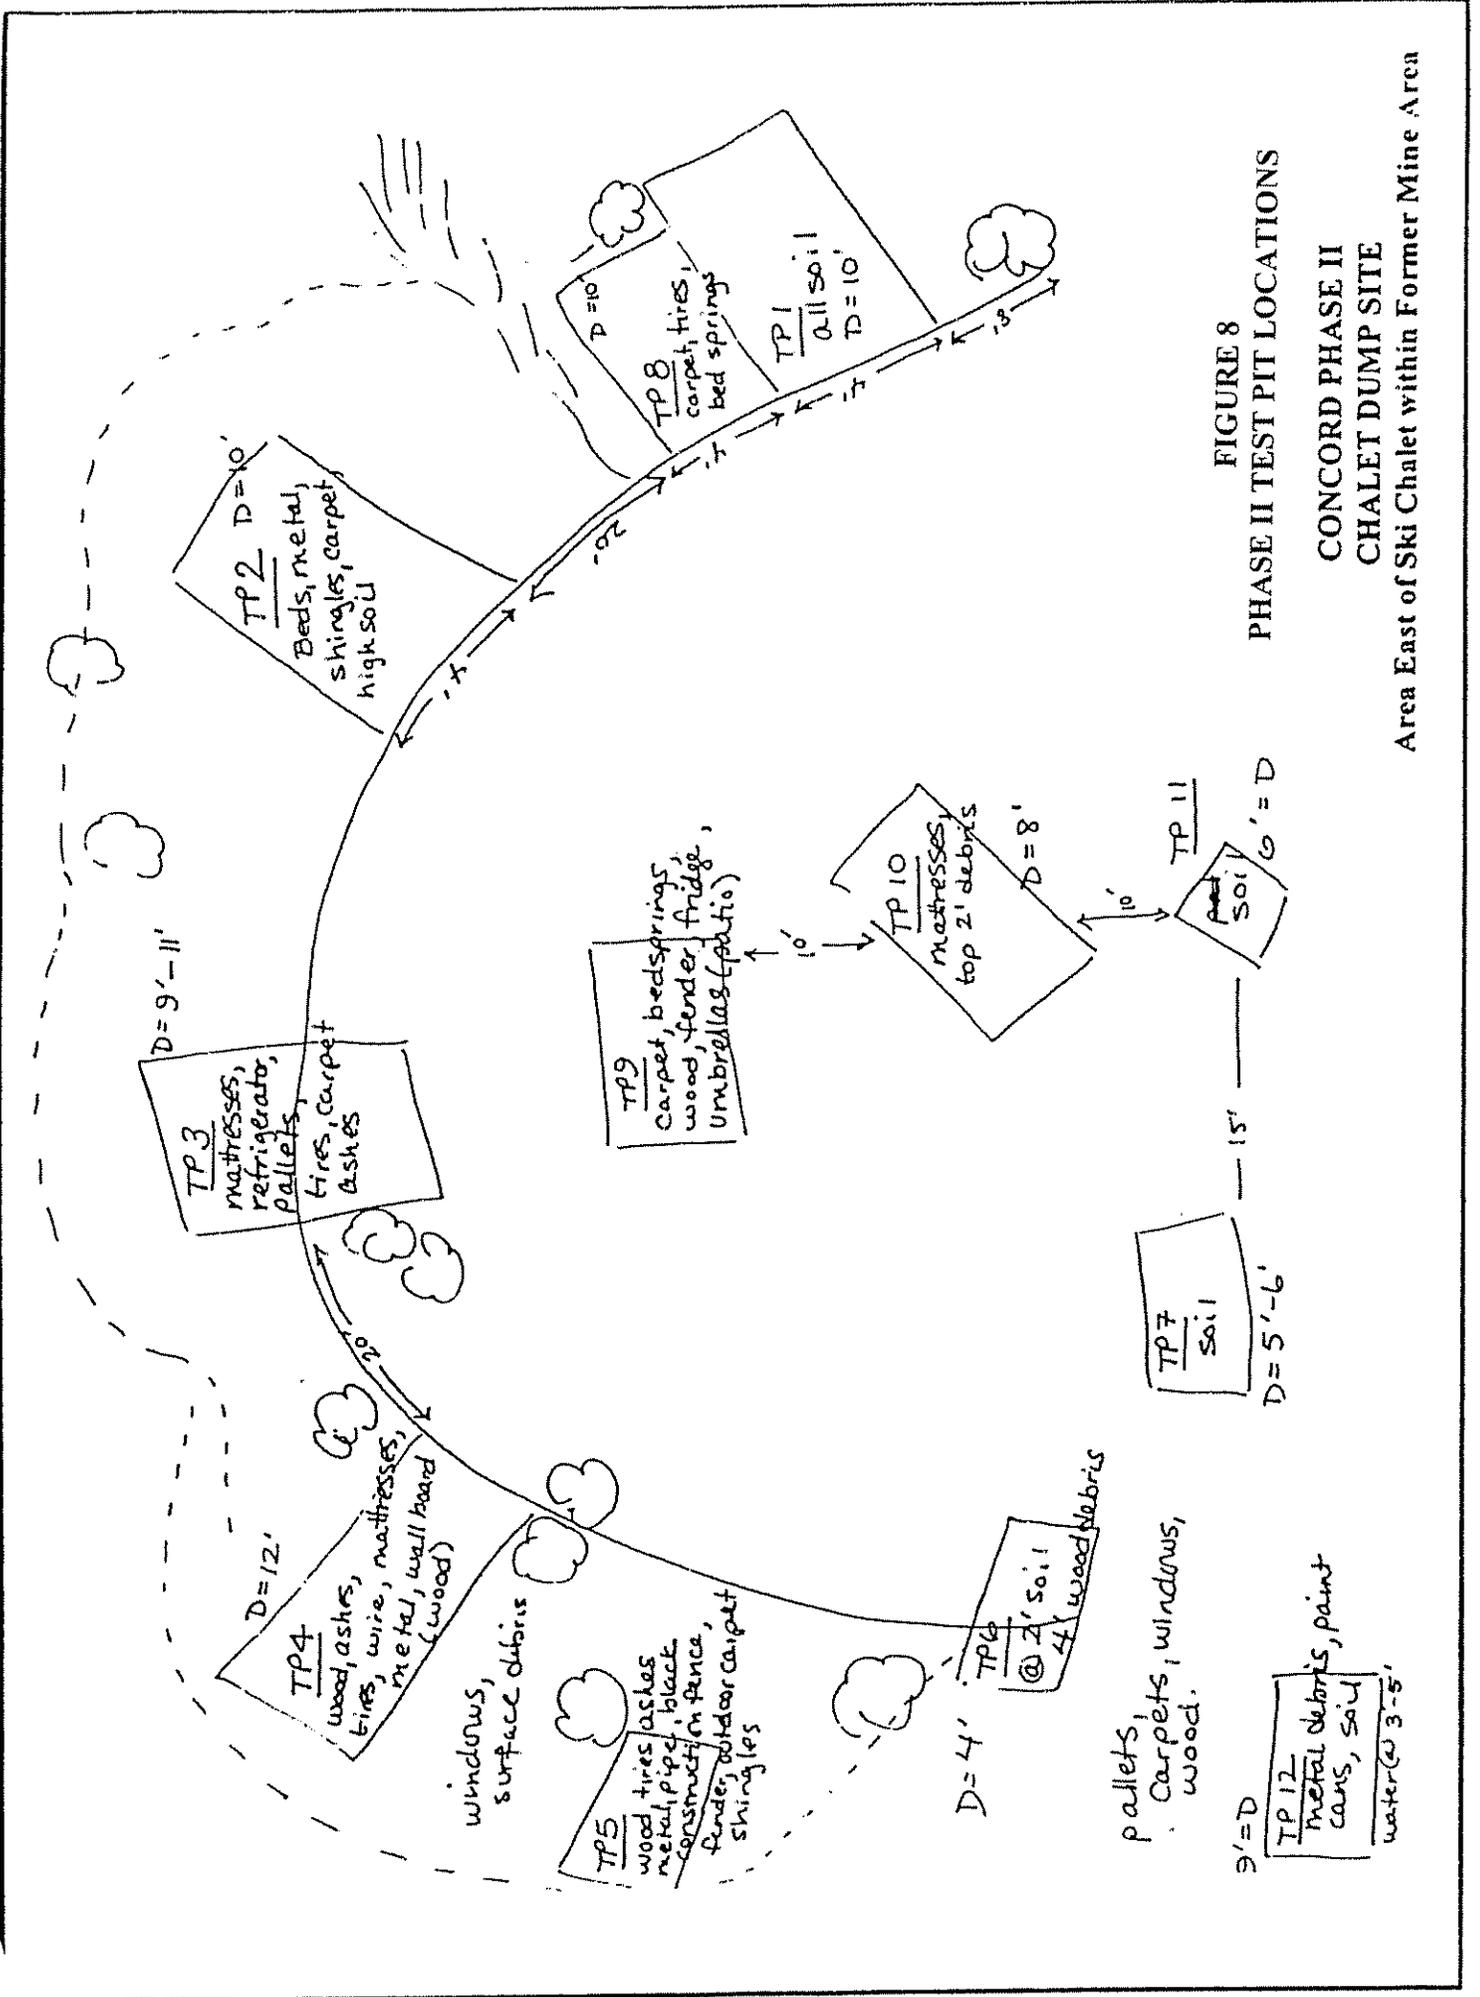
FIGURE 8
PHASE II TEST PIT LOCATIONS

CONCORD PHASE II
CHALET DUMP SITE

Area East of Ski Chalet within Former Mine Area

A total of twelve (12) test pits were installed in the dump during the Phase II ranging from depths of 5 to 12 feet bgs. One soil sample was collected from a composite of two test pits and analyzed to determine if the waste was hazardous. The results indicated that the waste was nonhazardous. Locations of the test pits completed during the Phase II are shown in Figure 8.

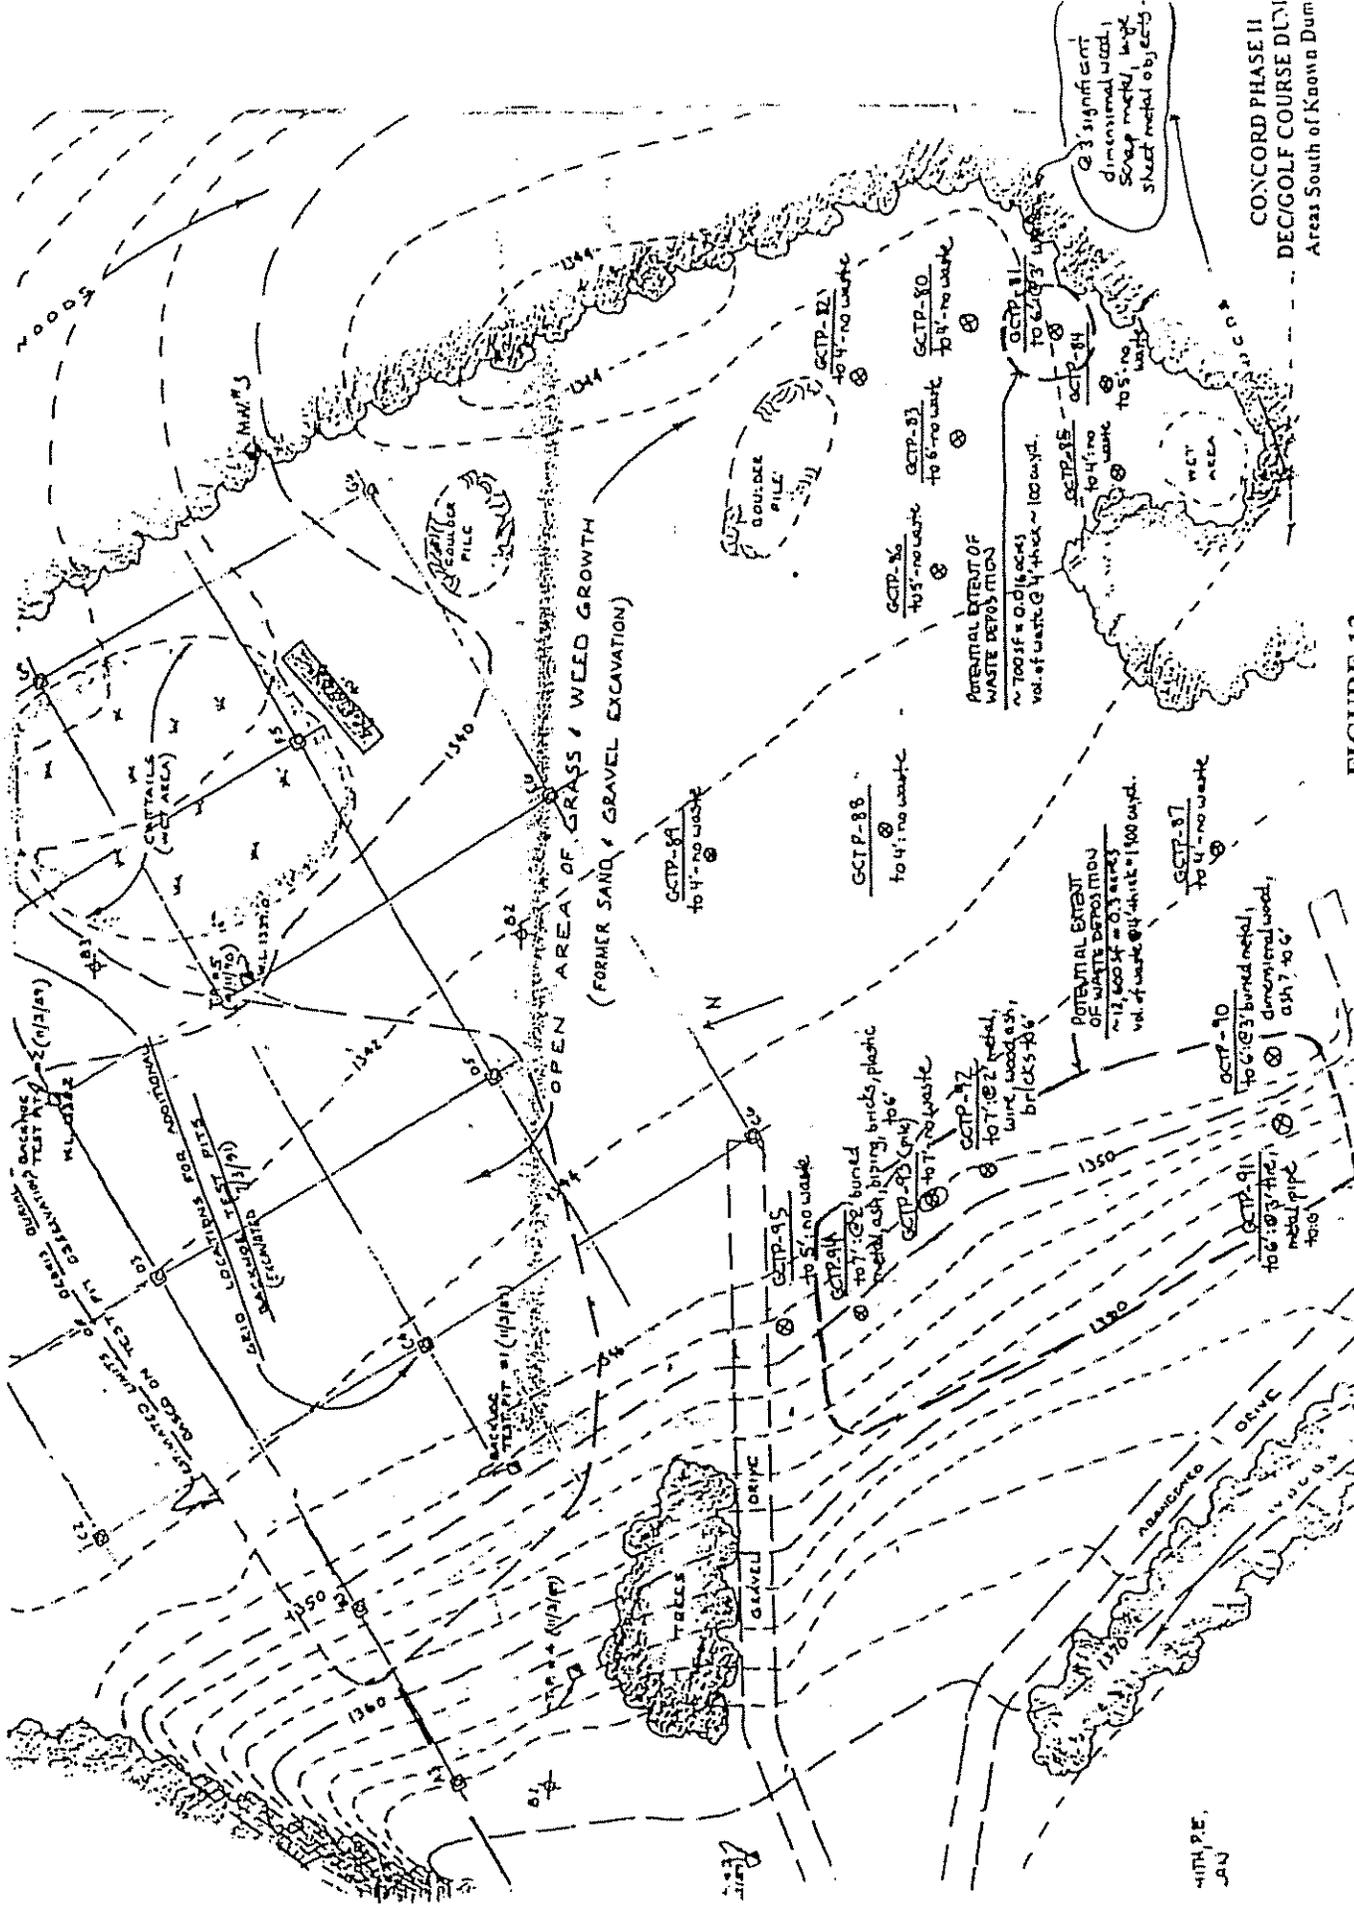
FIGURE 13

CONCORD PHASE II
DEC/GOLF COURSE DUM
Areas South of Kaonua Dum

PHASE II TEST PIT LOCATIONS - INTERNATIONAL GOLF COURSE DUMP

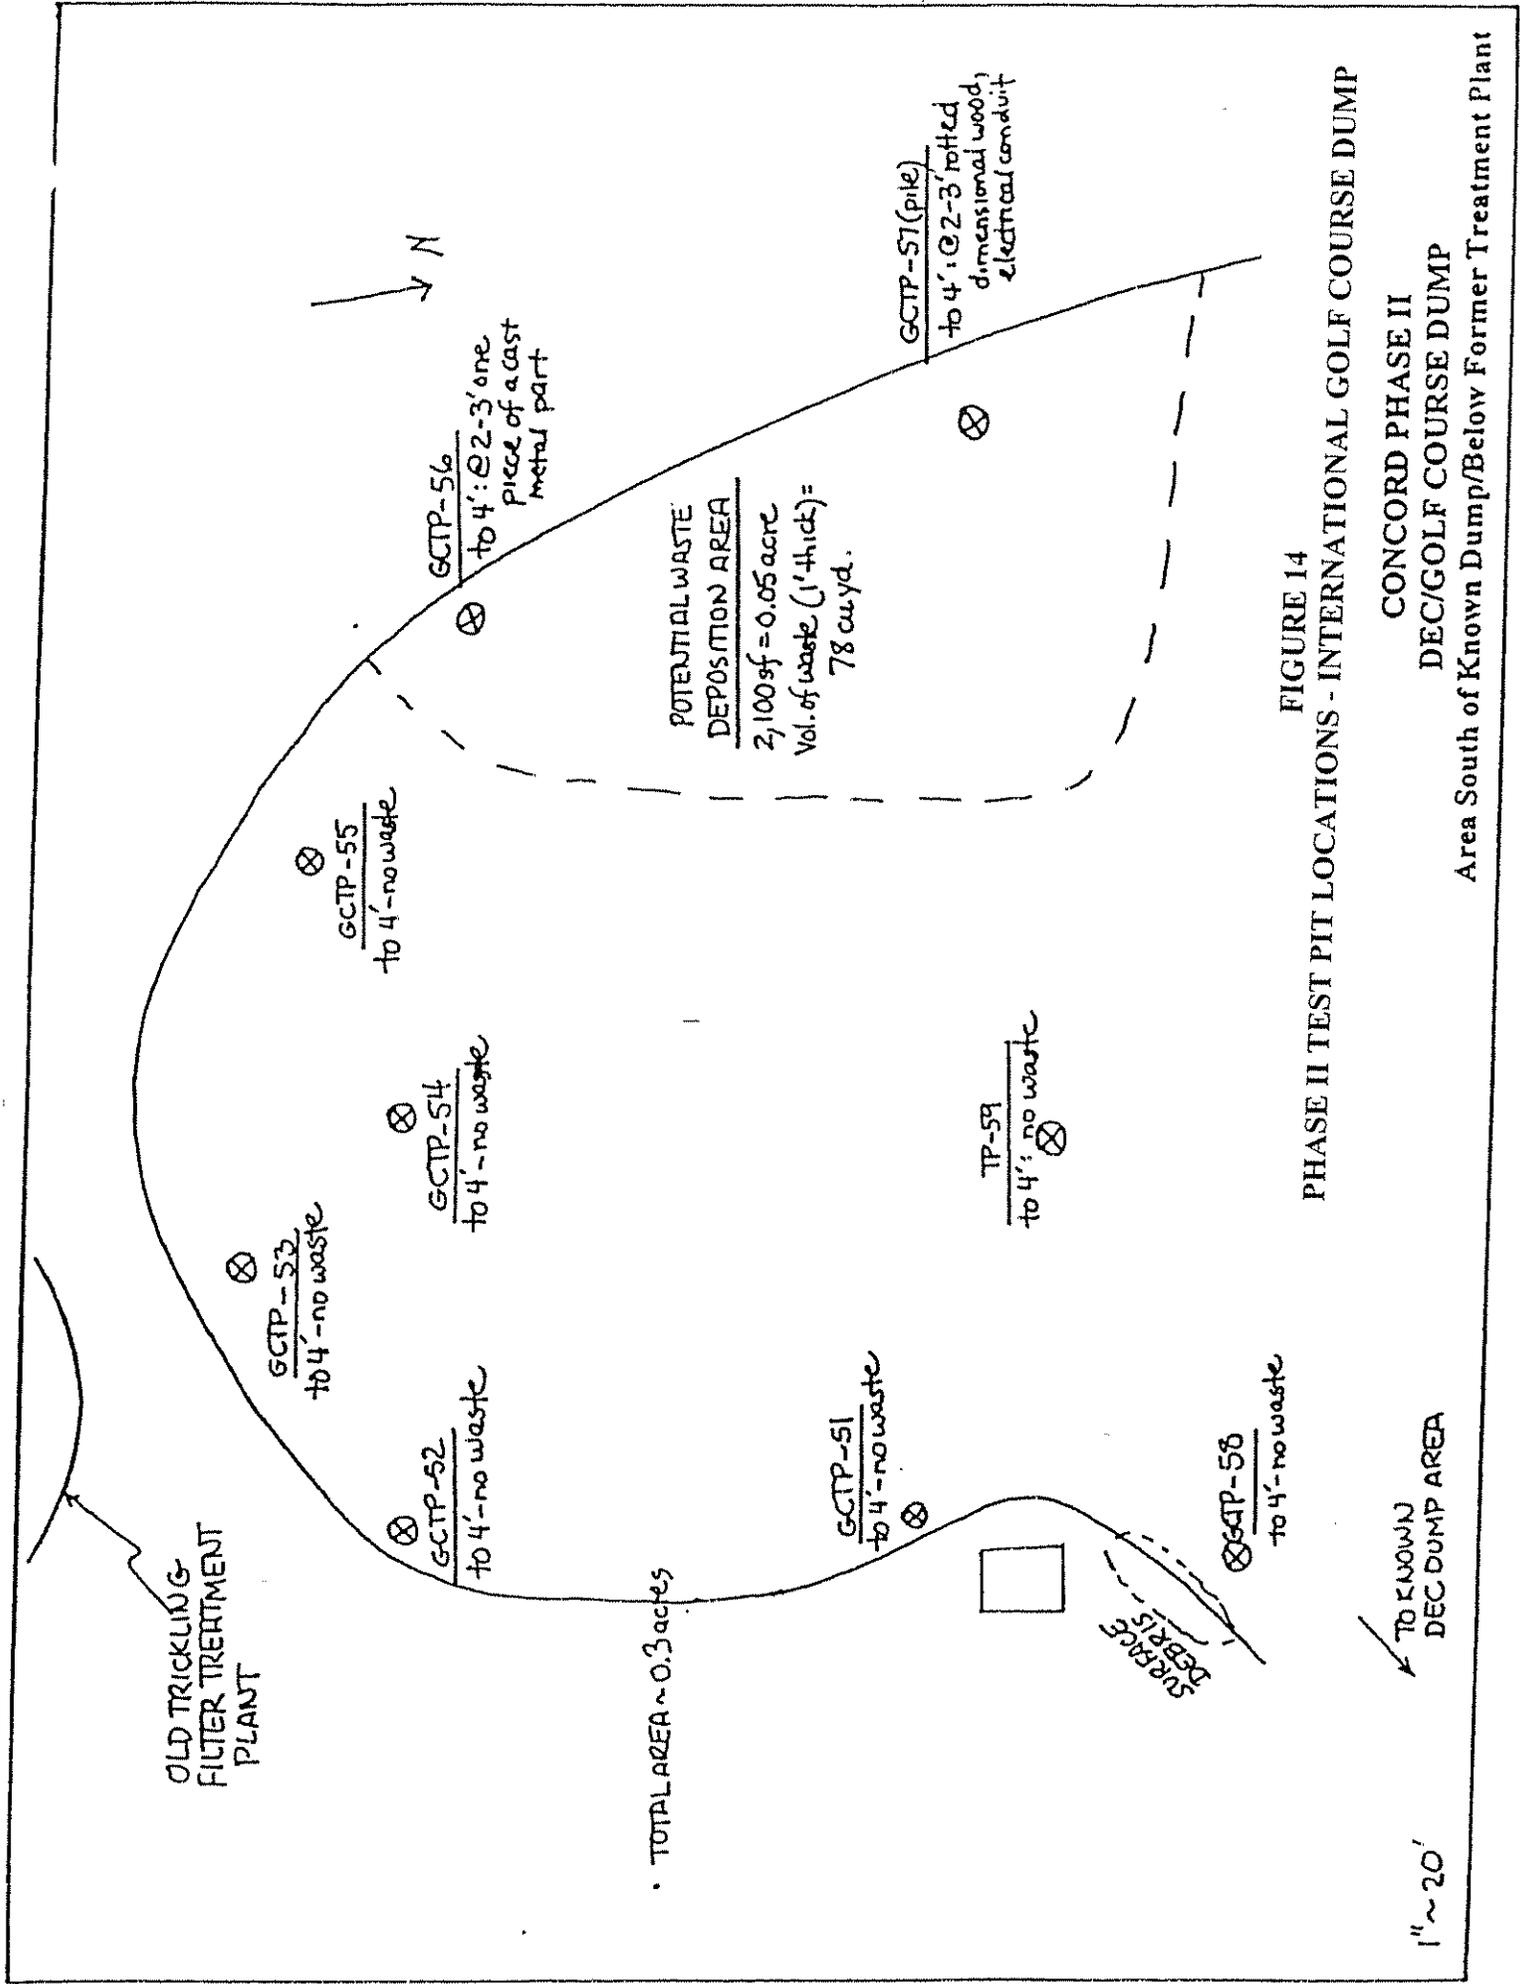
FIGURE 14
 PHASE II TEST PIT LOCATIONS - INTERNATIONAL GOLF COURSE DUMP
 CONCORD PHASE II
 DEC/GOLF COURSE DUMP
 Area South of Known Dump/Below Former Treatment Plant

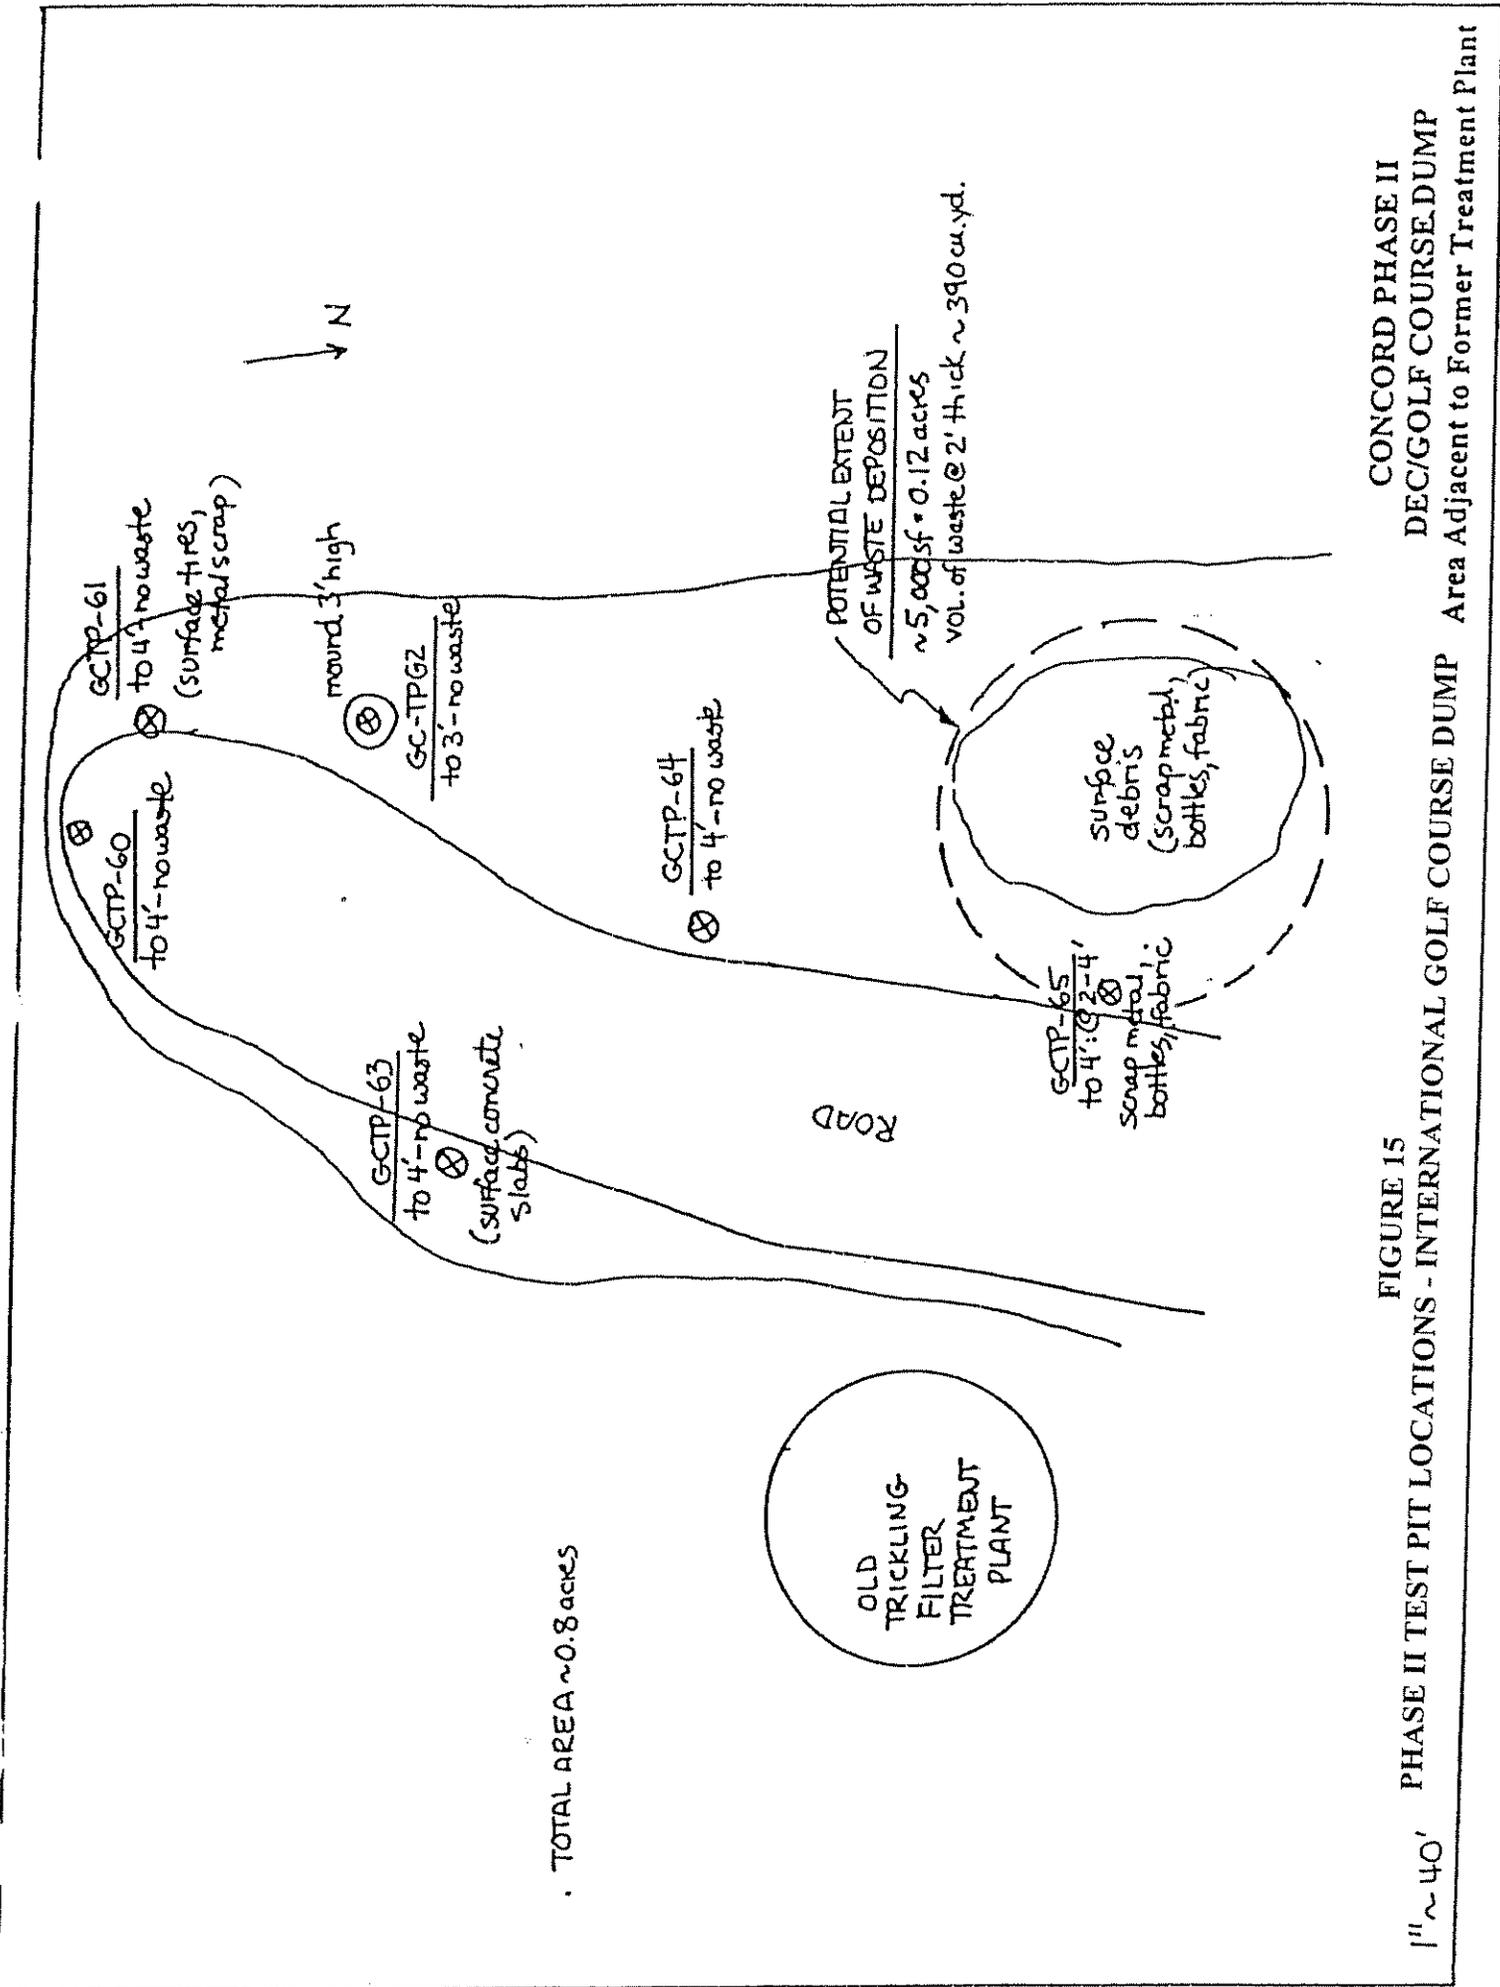
CONCORD PHASE II
 DEC/GOLF COURSE DUMP
 Area Adjacent to Former Treatment Plant

FIGURE 15
 PHASE II TEST PIT LOCATIONS - INTERNATIONAL GOLF COURSE DUMP

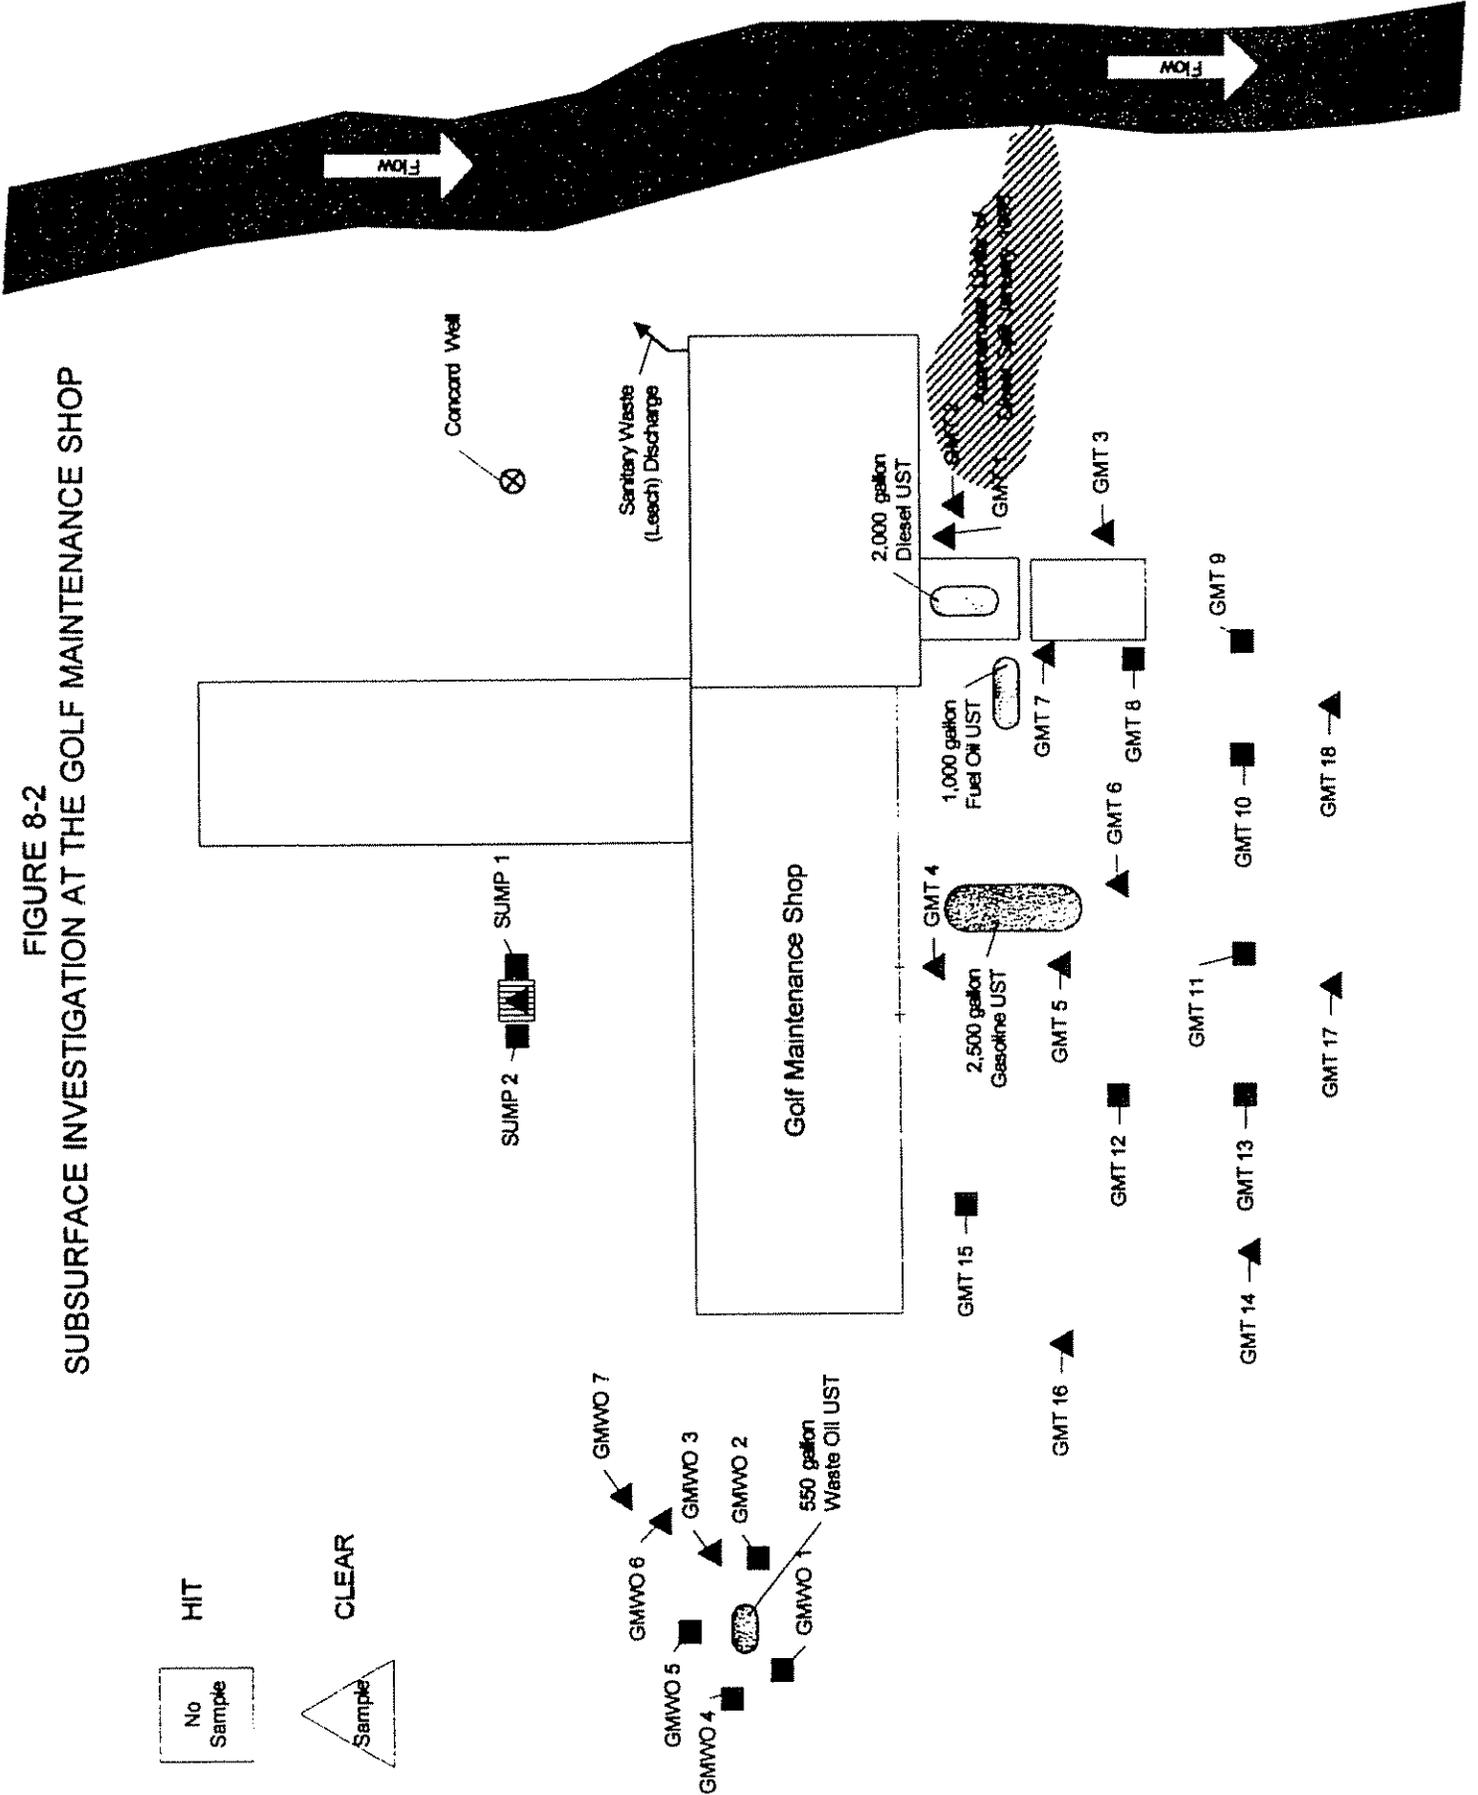
FIGURE 8-2
 SUBSURFACE INVESTIGATION AT THE GOLF MAINTENANCE SHOP

A total of eighteen (18) GeoProbe borings were placed in the vicinity of the gasoline, fuel oil and diesel USTs at the front of the Golf Maintenance Building. Boring placement was guided with the use of a PID unit to screen soil borings. The elevated VOC levels obtained as part of soil screening activities indicated that the front (northeast) portion of the Golf Maintenance Shop area is severely contaminated and remediation activities must be conducted promptly, given proximity to the Kiamesha Creek. Further, the close proximity of the Kiamesha Creek may have bearing on remediation options and NYSDEC approvals, such as the need to obtain a stream bank/bed disturbance permit. Analytical results for the eleven (11) samples obtained in this area indicate high concentrations of gasoline constituents.

Seven (7) borings were obtained in the vicinity of the 550 gallon waste oil tank. Field observations, including preliminary soil screening information, indicates that this area contains petroleum contaminated soils. Based on soil sampling activities, four (4) soil samples were obtained from three (3) borings in this area. Two (2) of the samples were obtained from one boring to obtain an indication of the concentration of petroleum contamination at varying depths. The analytical results reveal high concentrations of gasoline parameters and confirm suspected petroleum product contamination.
