**REMEDIAL INVESTIGATION AND
INTERIM REMEDIAL MEASURE
(RI/IRM) WORK PLAN**

**THE CONCORD HOTEL & RESORT SITE
Concord Road, Kiamesha Lake
Thompson, NY 12751**

October 2004

**JM Associates, Inc.
225 Railroad Ave
Bedford Hills, NY 10507**

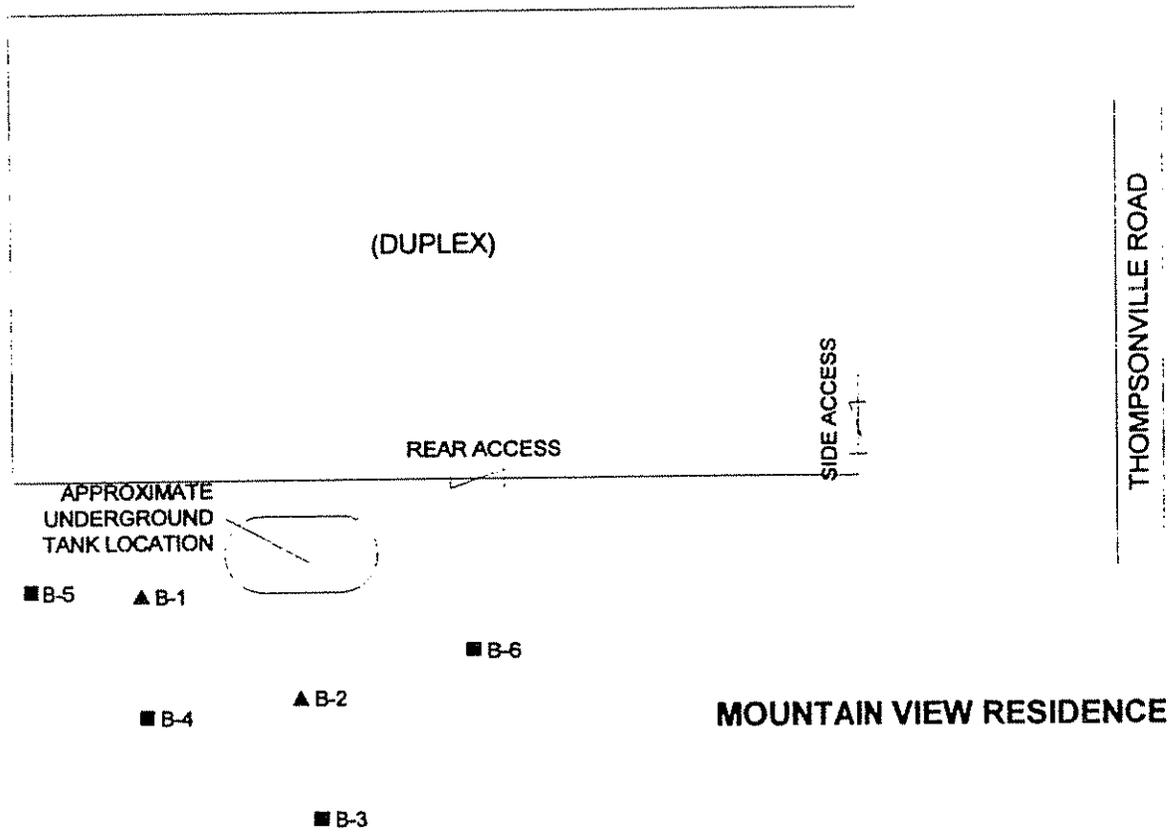
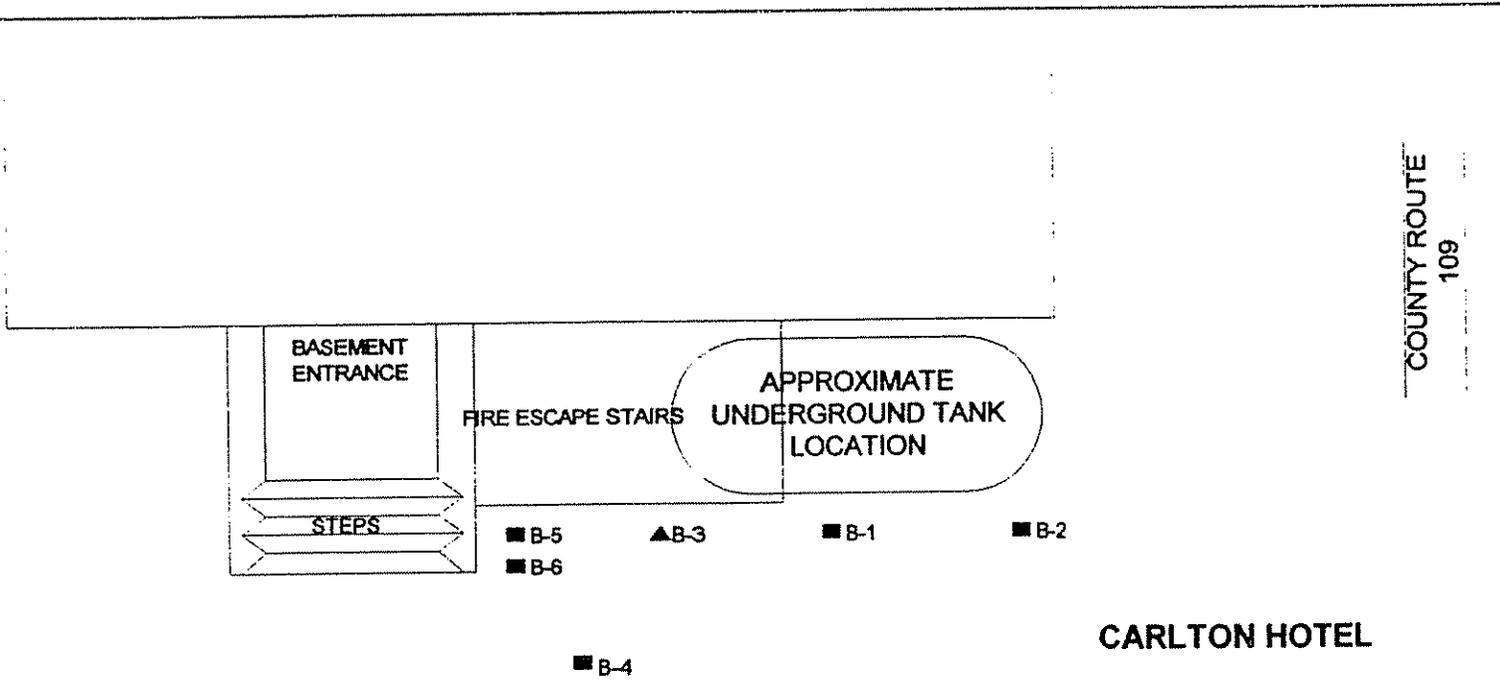
**FIGURE 8-3
SUBSURFACE INVESTIGATIONS AT THE CARLTON HOTEL
AND THE MOUNTAIN VIEW RESIDENCE**

On September 16, 1998, Zebra Environmental placed six (6) GeoProbe borings in close proximity to the UST at the site. Figure 8-3 depicts the approximate location of each boring placed at this site. Each boring allowed for the removal and evaluation of subsurface soils to a maximum depth of approximately 10 feet. An OVM was utilized to screen soils to determine if organic vapors were present. Based on the results obtained at the site, it appears that a release of heating oil has occurred from the UST. Table 8-4 presents the analytical results for the samples obtained. Table 8-1 provides NYSDEC STARS 8021 and 8270 threshold standards for

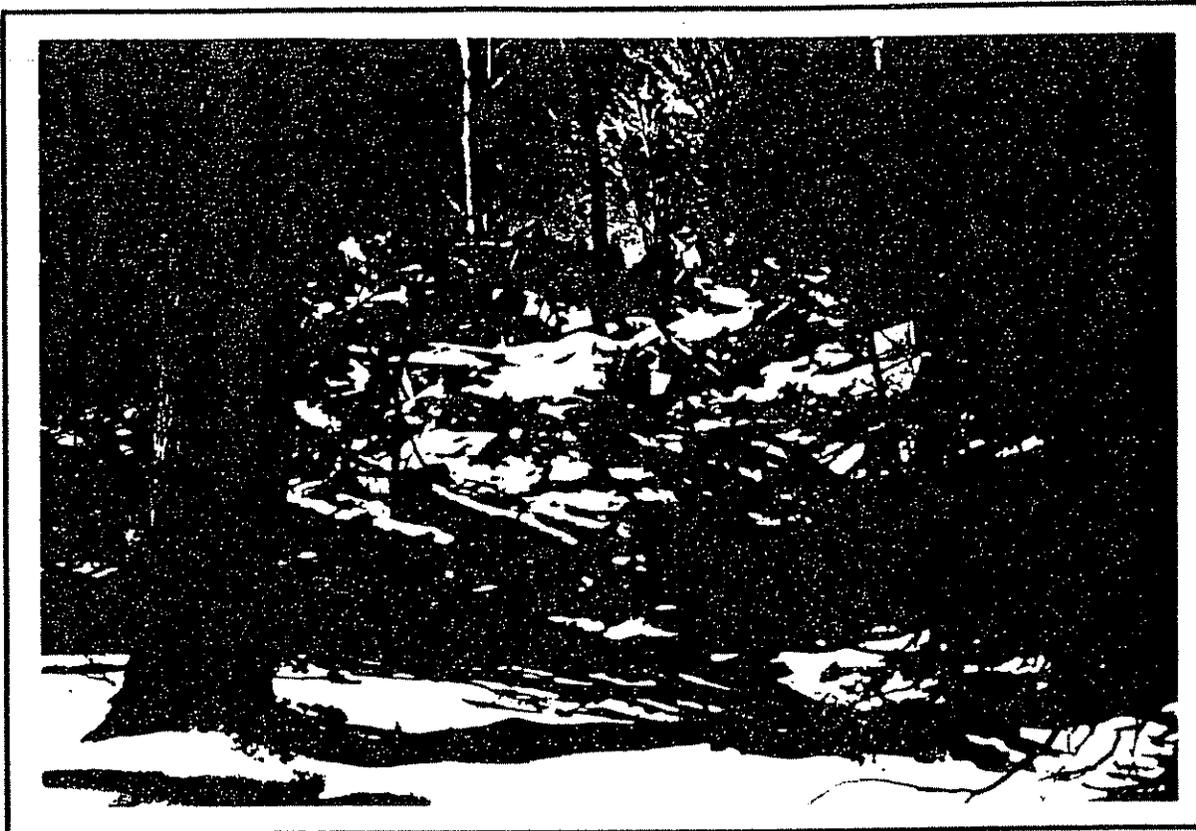
Photo No. 11 - A view of surface waste at the Chalet dump site.

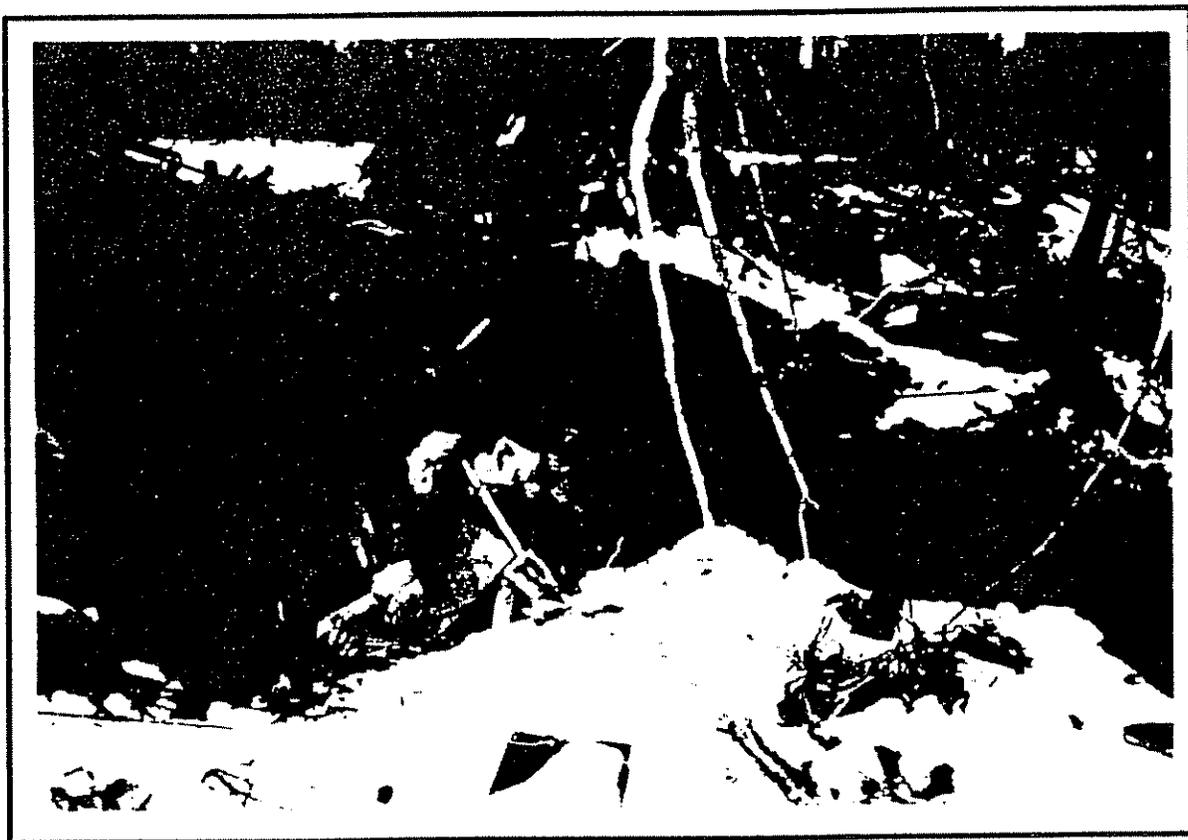
Photo No. 16 - Excavated waste at Casino dump site.

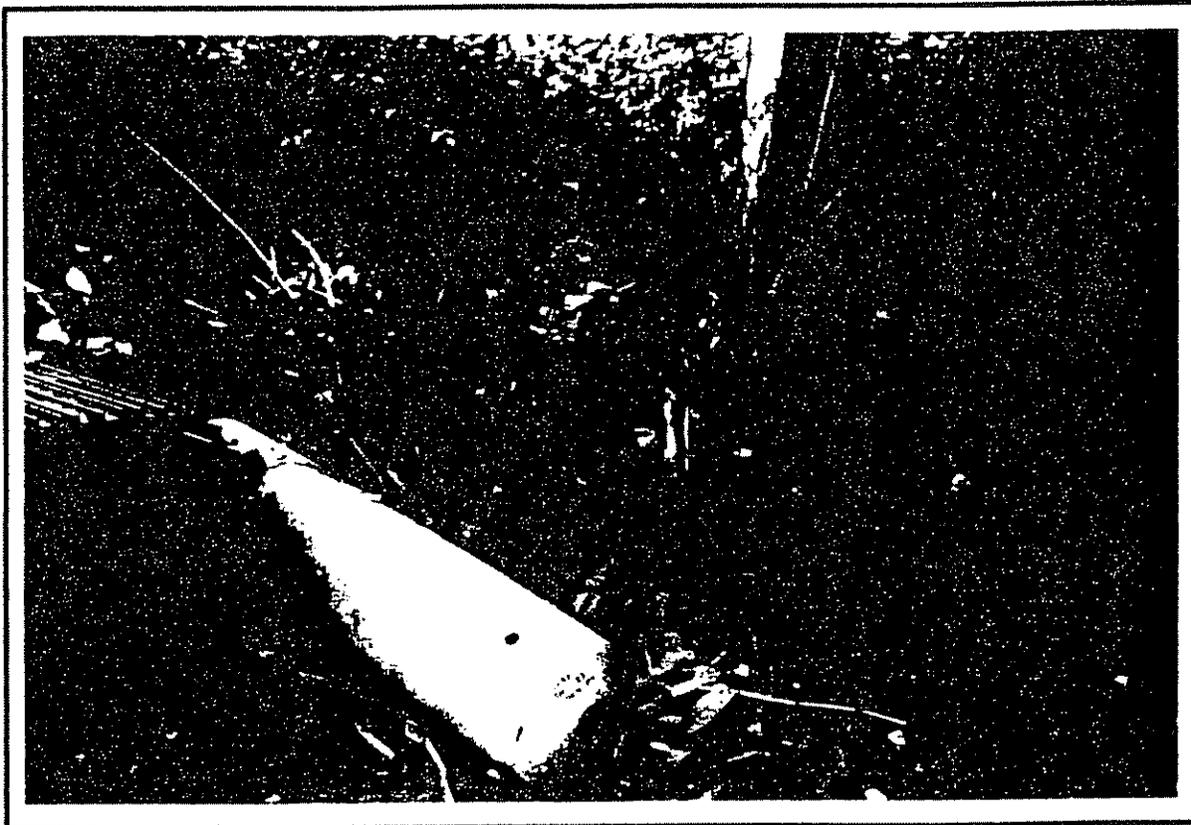
Photo No. 19 - View of excavated waste materials at the Cemetery dump site.

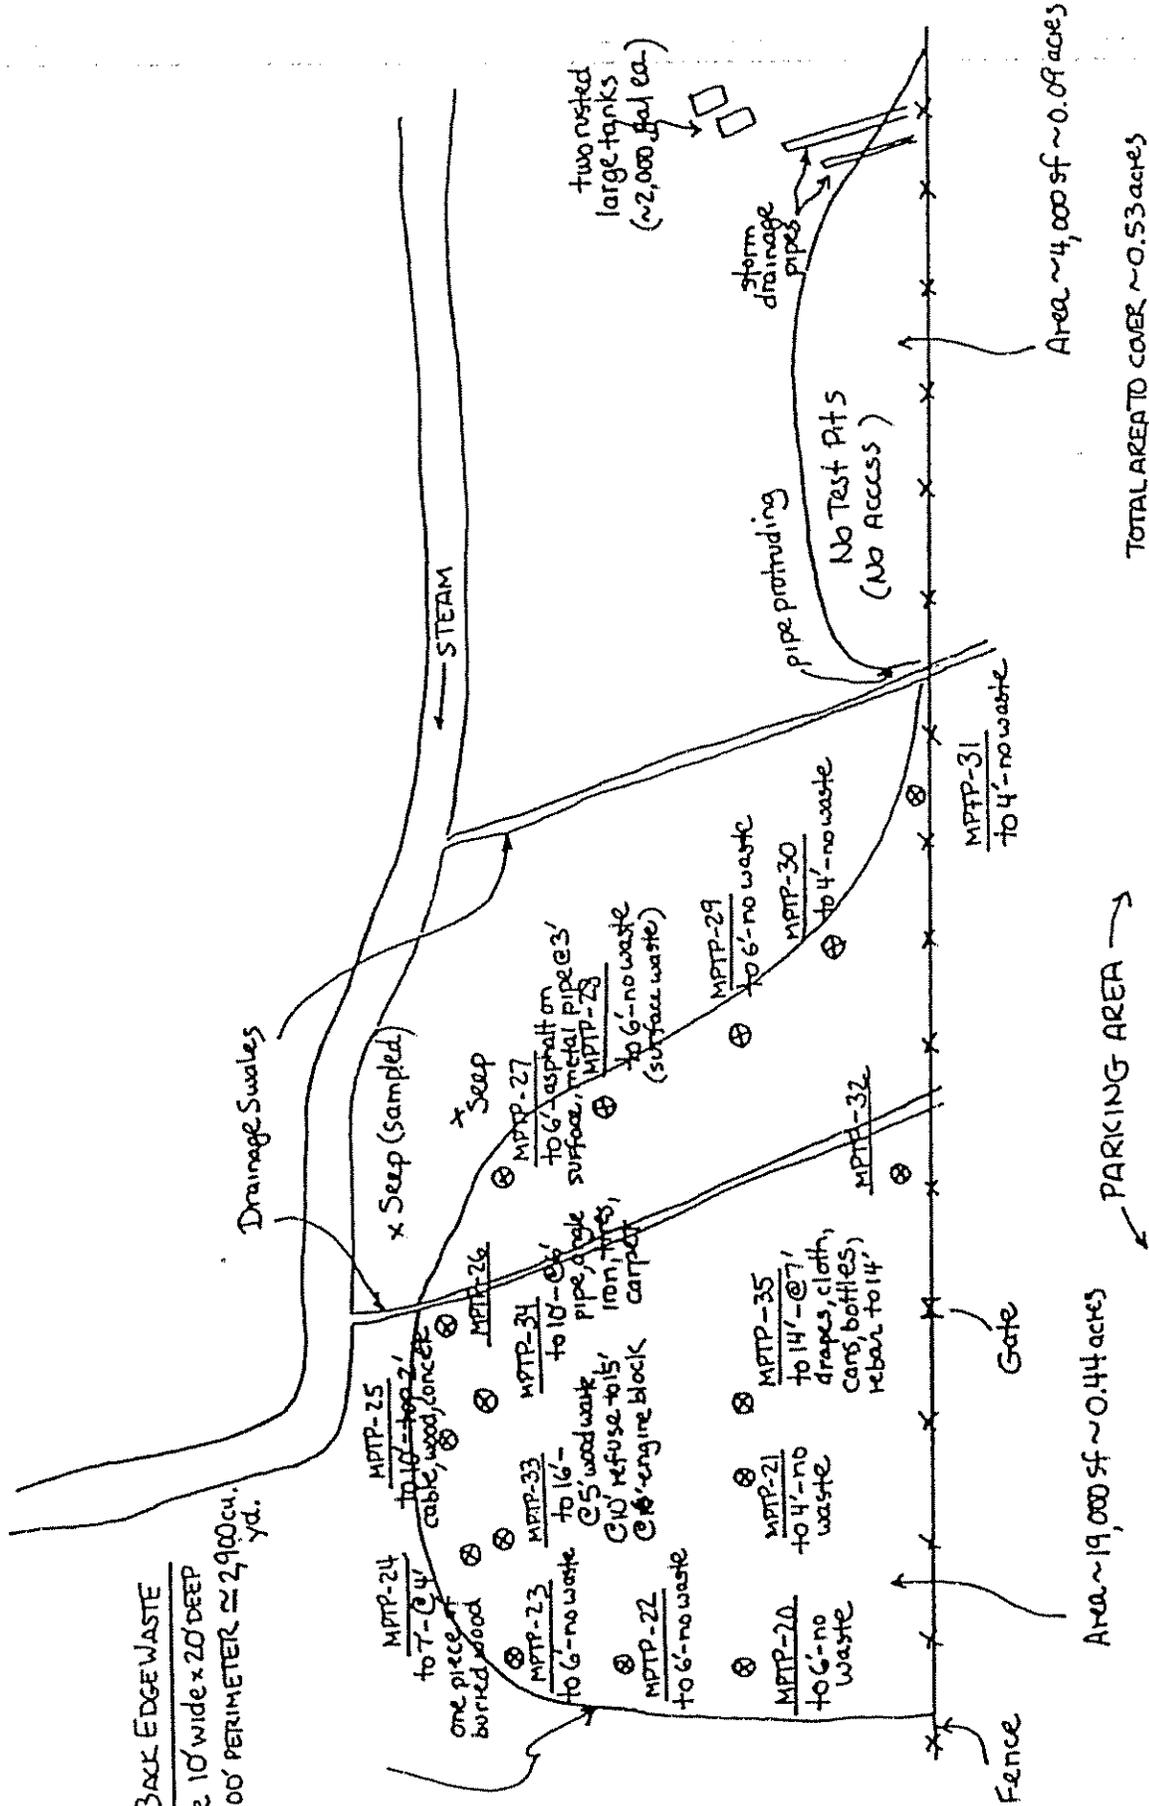
**CONCORD PHASE II
MAIN PARKING DUMP**

PULL BACK EDGEWASTE

Assume 10' wide x 20' DEEP
x 400' PERIMETER ≈ 2,900 cu. yd.

TOTAL AREA TO COVER ~0.53 acres

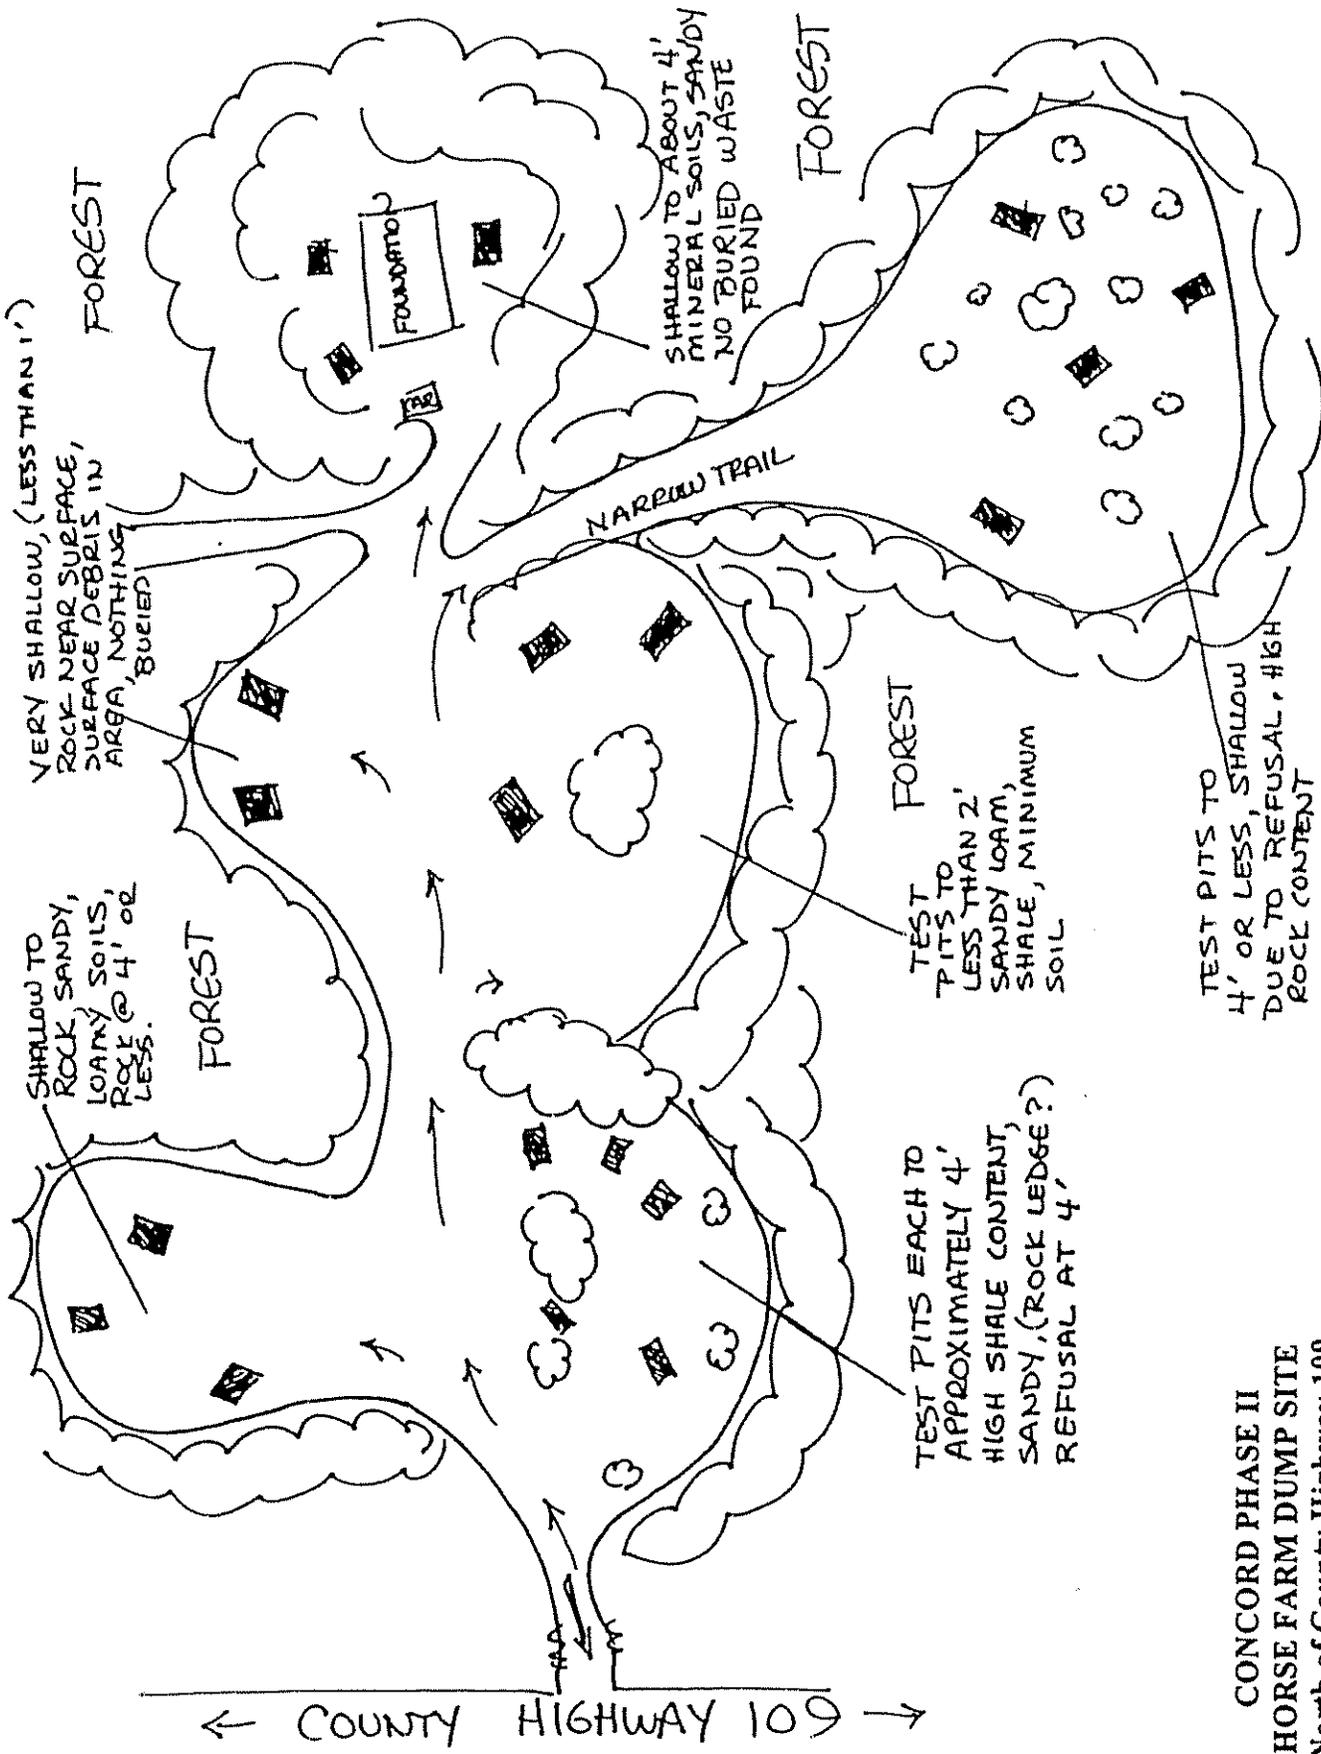
VERY SHALLOW, (LESS THAN 1')
 ROCK NEAR SURFACE,
 SURFACE DEBRIS IN
 AREA, NOTHING
 BURIED

SHALLOW TO
 ROCK SANDY,
 LOAMY SOILS,
 ROCK @ 4' OR
 LESS.
