Exhibit VIII.C.1.e (Geological or Structural Defect in Project Site):

1. Geological Characteristics of Project Site

A detailed description of the Project Site subsurface conditions and geological conditions relative to the proposed development are provided in the 2 June 2014 Preliminary Geotechnical Engineering Study Report, prepared by Langan Engineering, Environmental, Surveying, and Landscape Architecture, D.P.C. (See Exhibit VIII.C.1.f.). Engineering recommendations to address the general geological conditions at the site are summarized below.

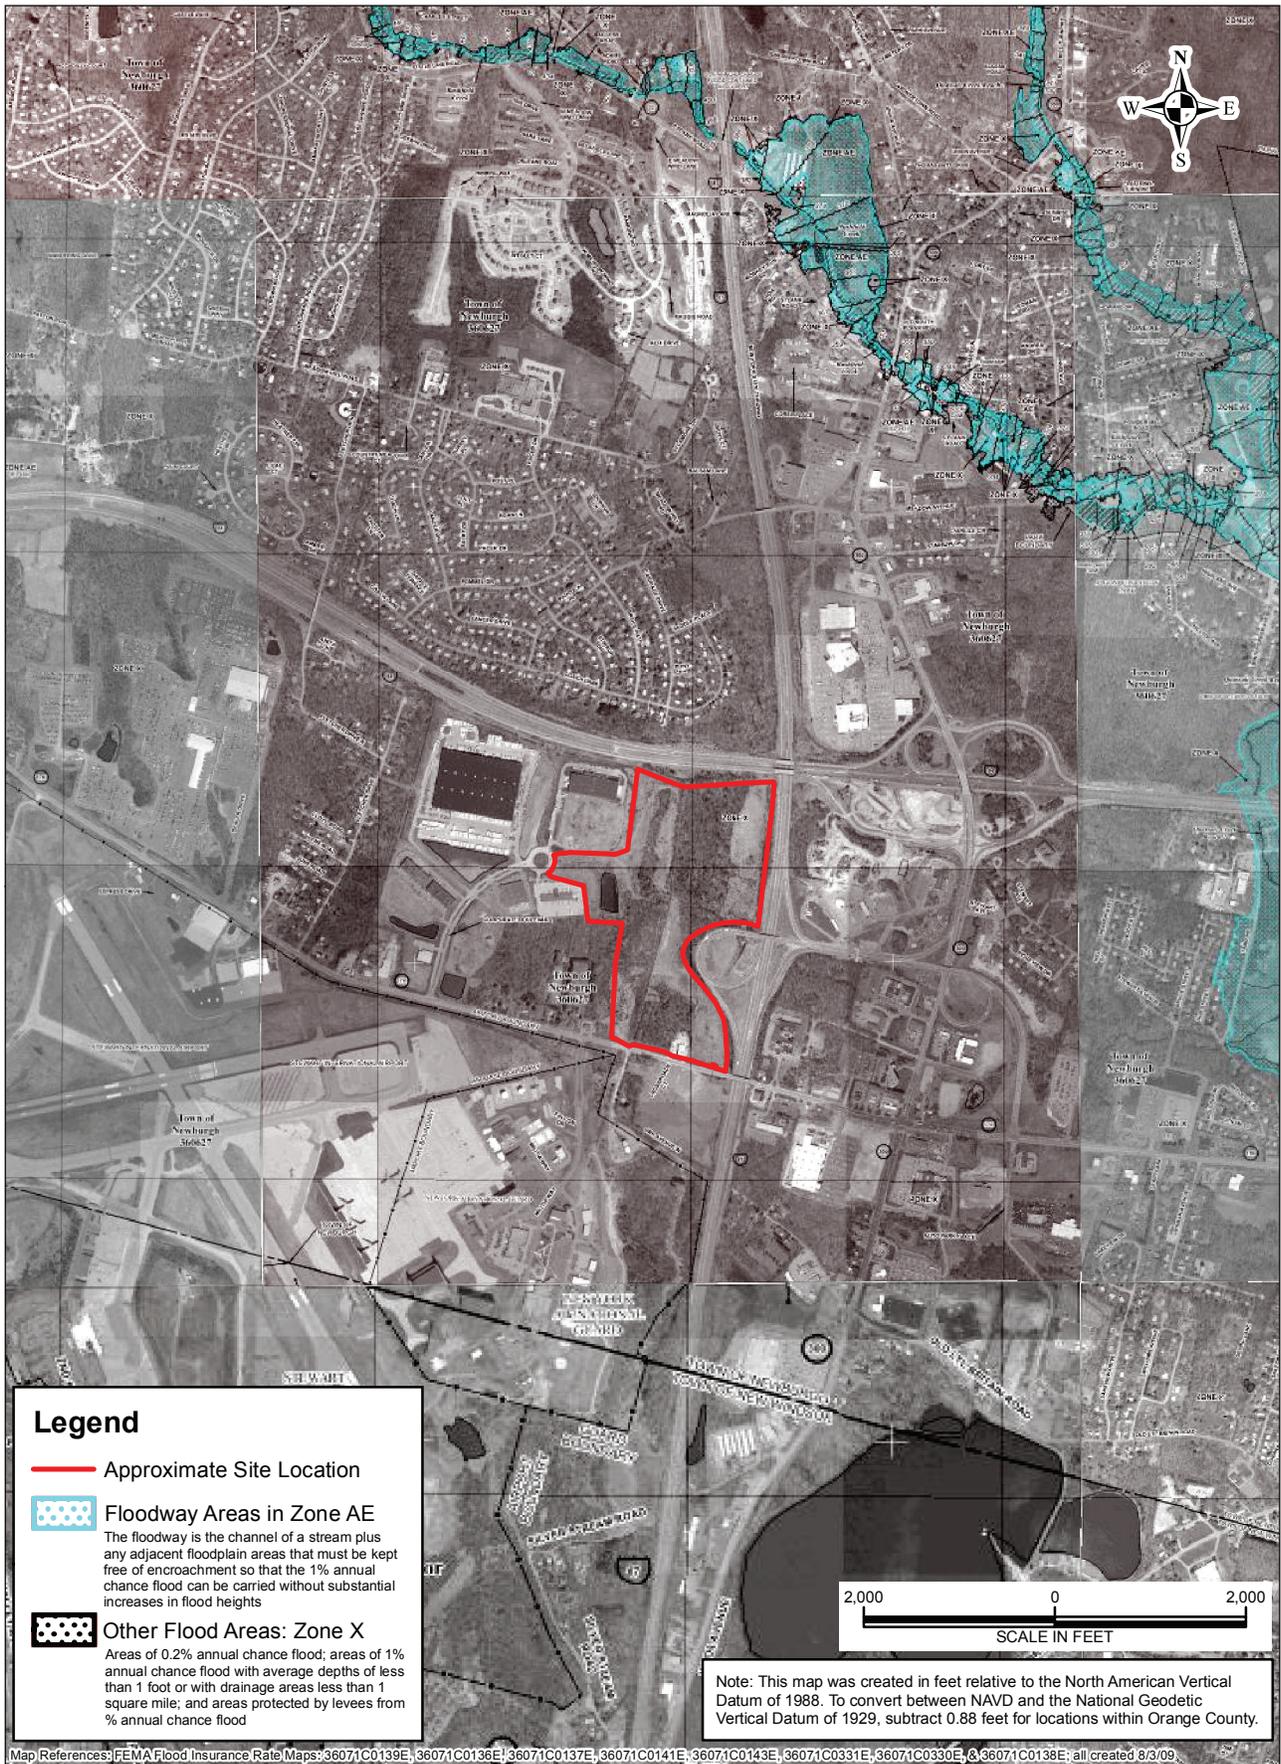
Exhibit VIII.C.1.e. - Figure 1
Exhibit VIII.C.1.e. - Figure 2

FEMA Map
Steep Slope Analysis

The Project Site is not located in a floodplain and has no history of flooding. The Federal Emergency Management Agency (FEMA) Flood Insurance Rate Map (FIRM) Panel 36071C0129E, dated 8/3/09, does not show any floodplains on or near the Project Site (See Figure 1 - FEMA Map).

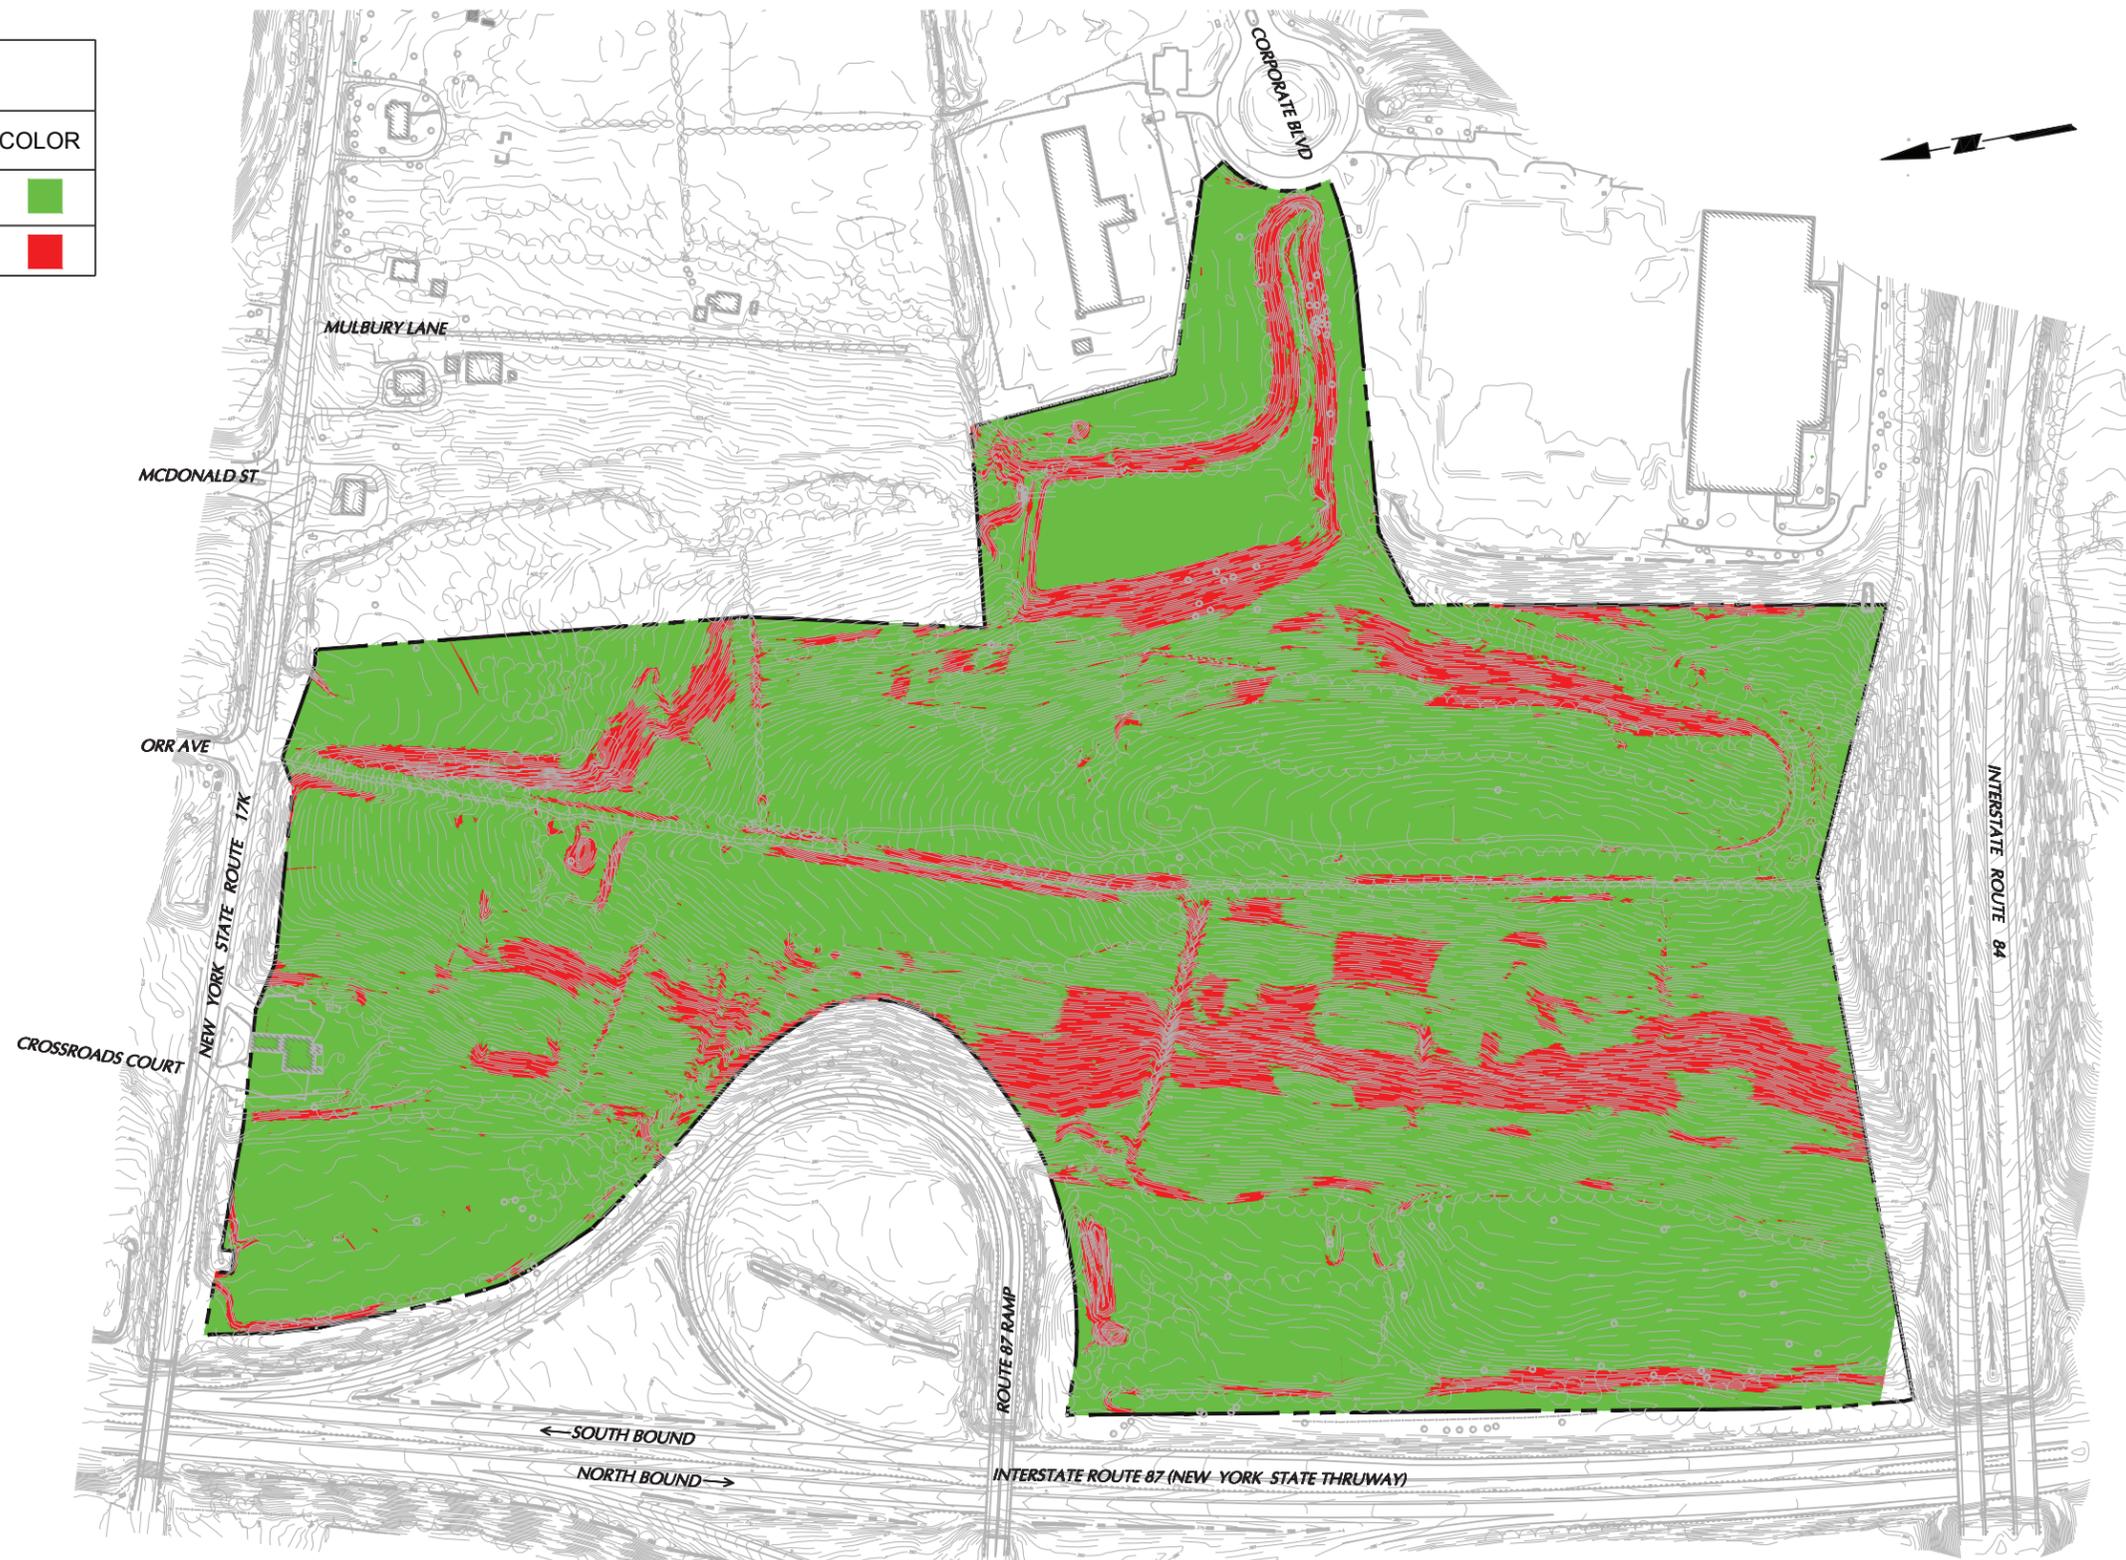
STEEP SLOPE ANALYSIS
FIGURE 2

SLOPES TABLE		
SLOPE	AREA (AC)	COLOR
0% TO 25%	73.1	■
≥ 25%	15.4	■

A steep slope is defined by the zoning code for Newburgh, New York as a contiguous area of at least 5,000 square feet containing a slope with a topographical gradient equal to or greater than 25%. The site consists of steep slopes on the east, west, and south portions of the site (See Figure 2 - Steep Slope Analysis). Steep slopes on both the east and the west sides of the site may present grading and drainage challenges. We designed the proposed development to address these challenges with pocket detention basins, stepped retaining walls, a multi-level garage, and a winding boulevard to reach the top of the site. Because it is one of the highest points in the area, steep slopes were used as a benefit, providing breathtaking views and a welcoming experience to the site.
